Ecosystems Past and Present:

An Introduction

Bringing the science of ecology to all land-use decisions

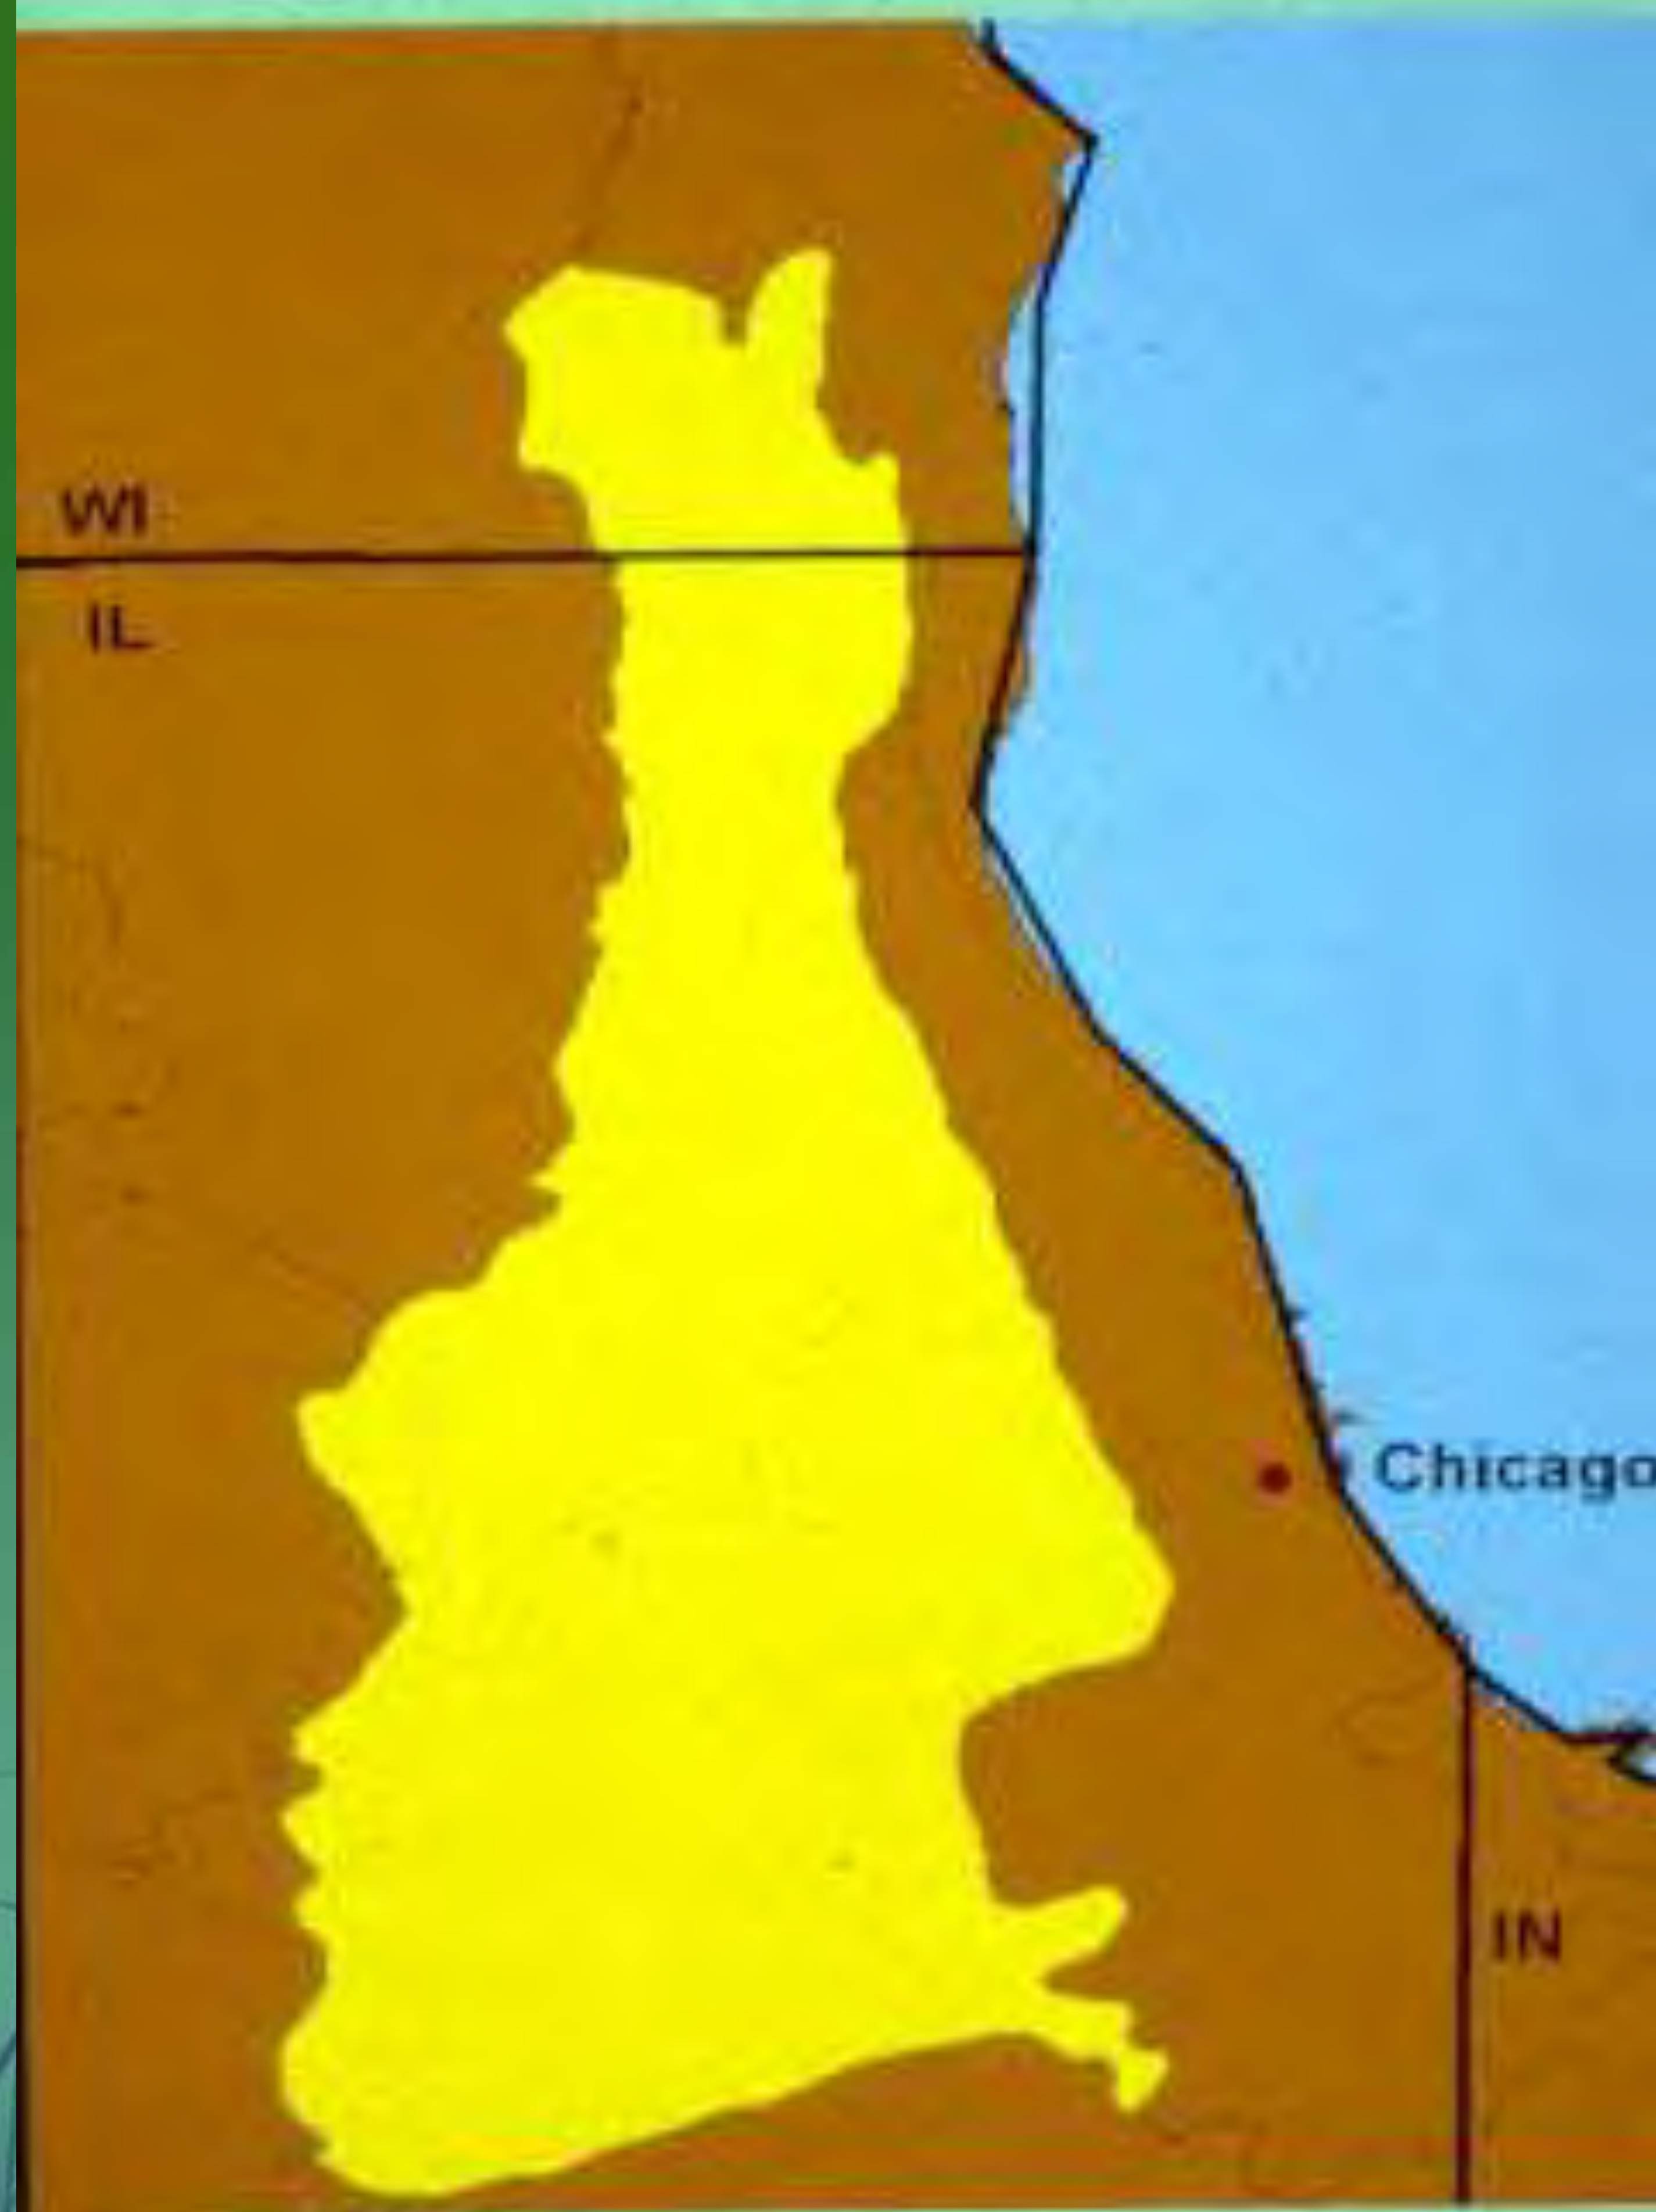
STAFF GAGE DATA 1899

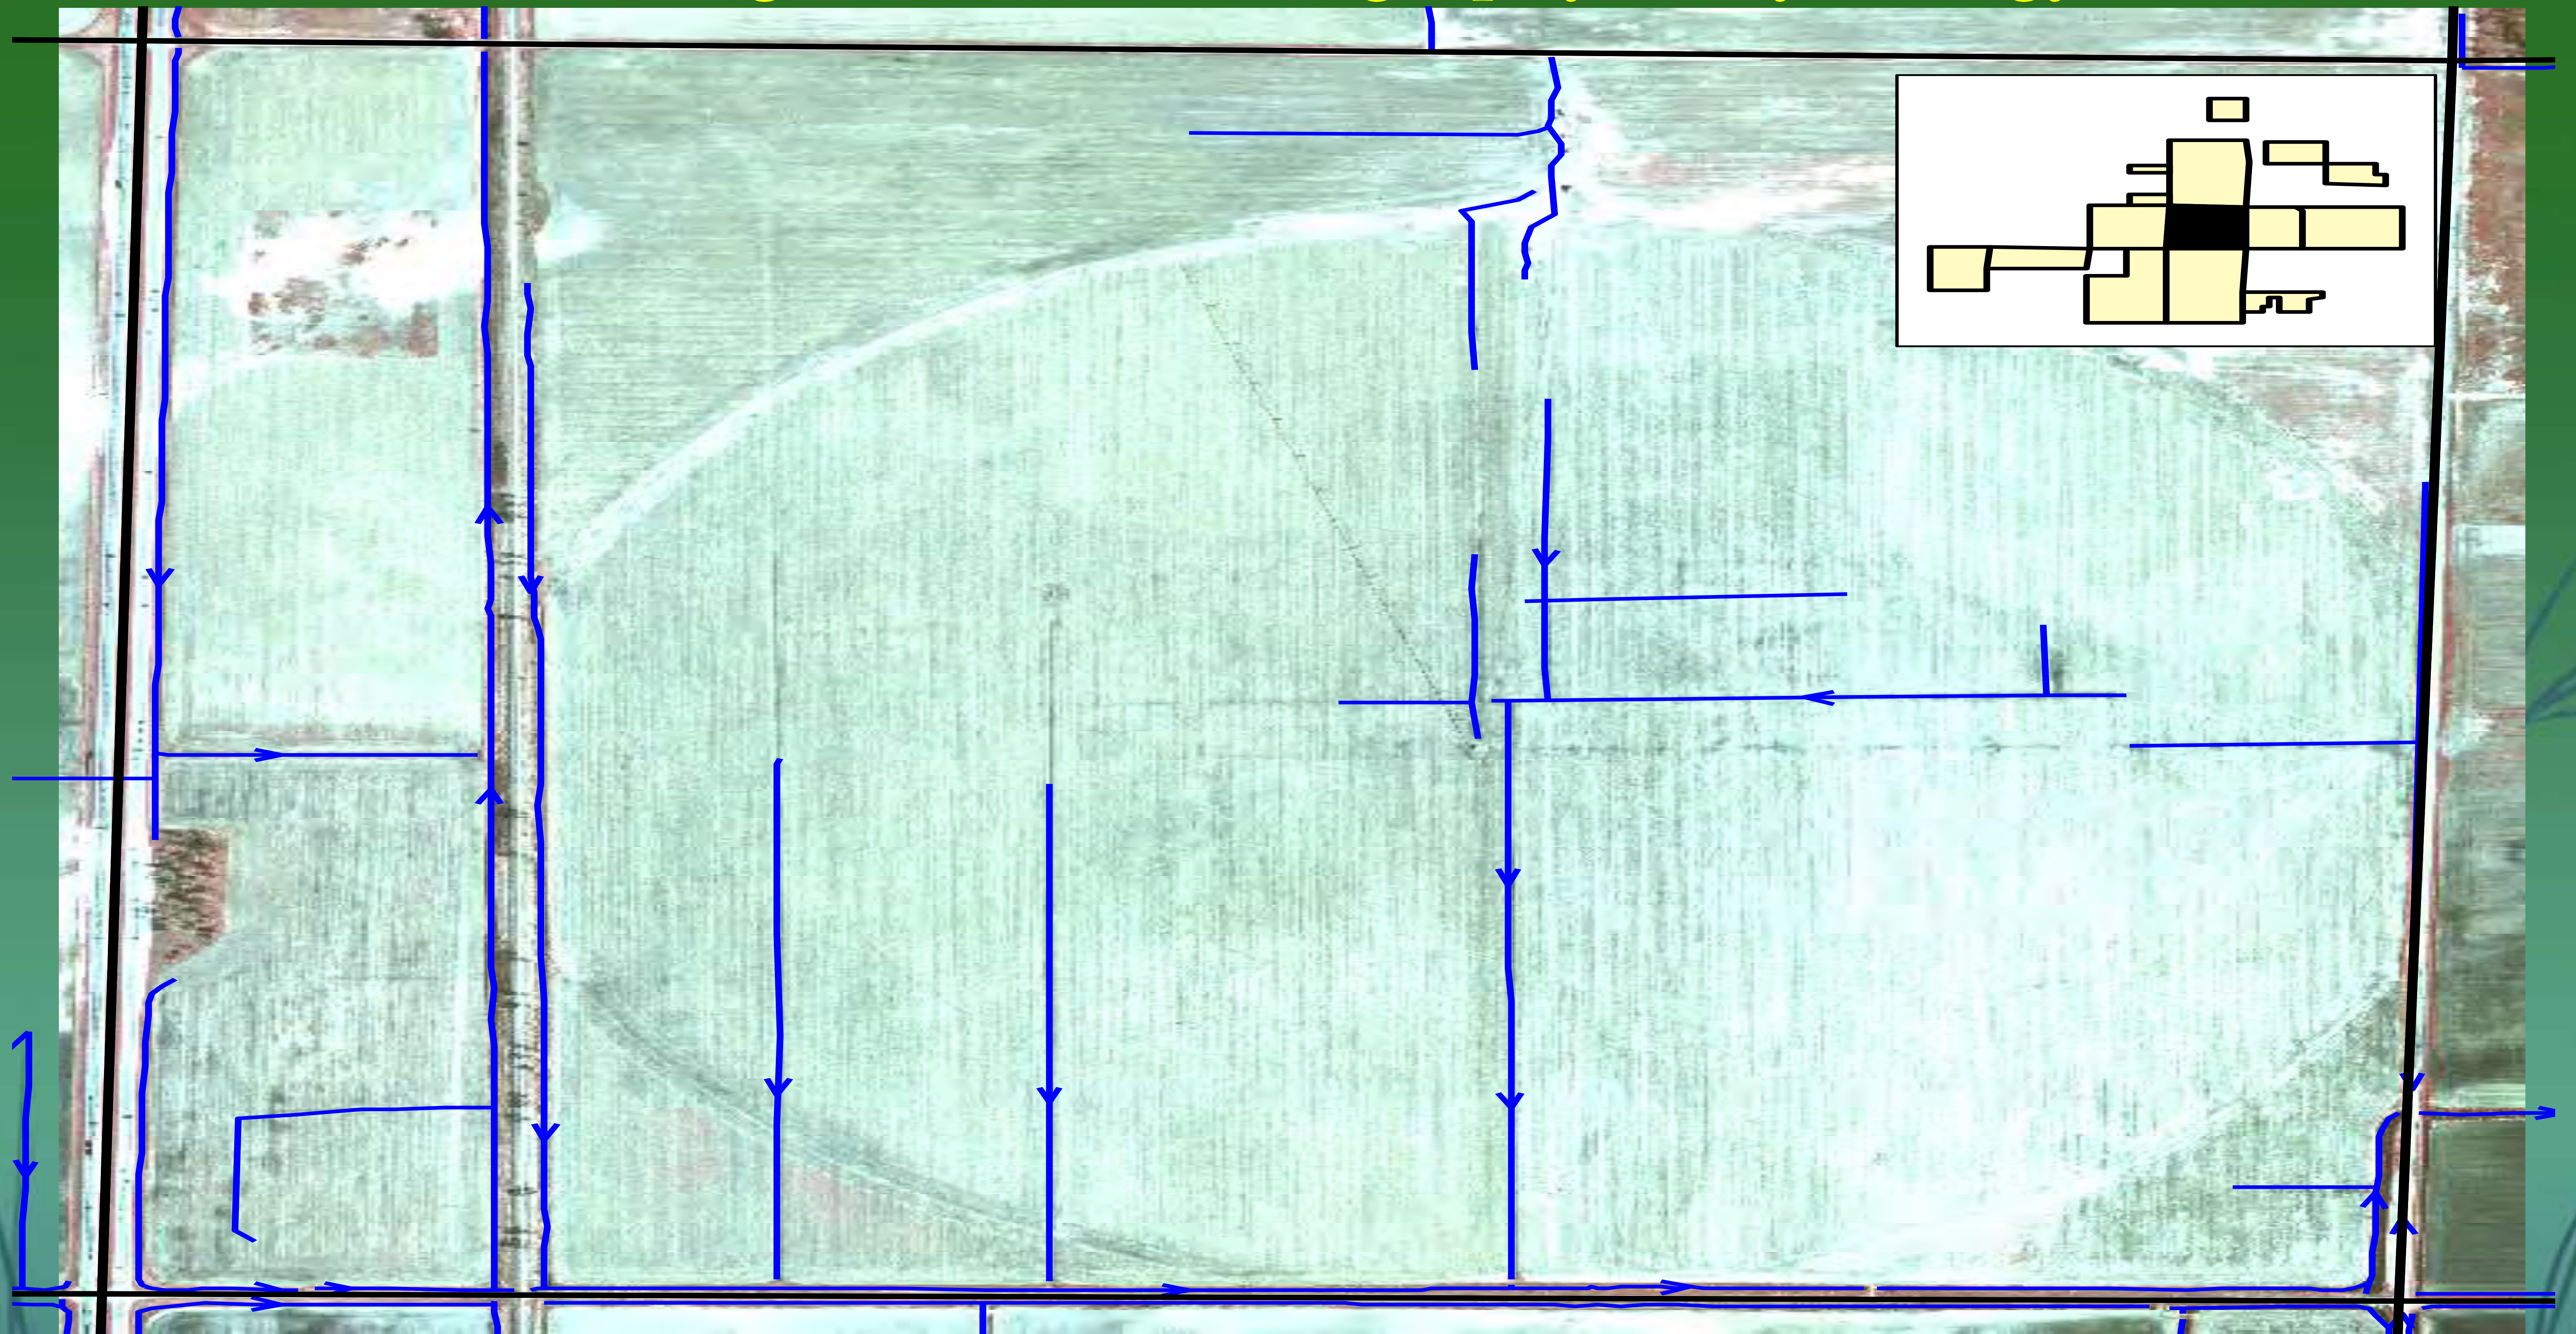
1997 Digital Aerial Photography & Hydrology

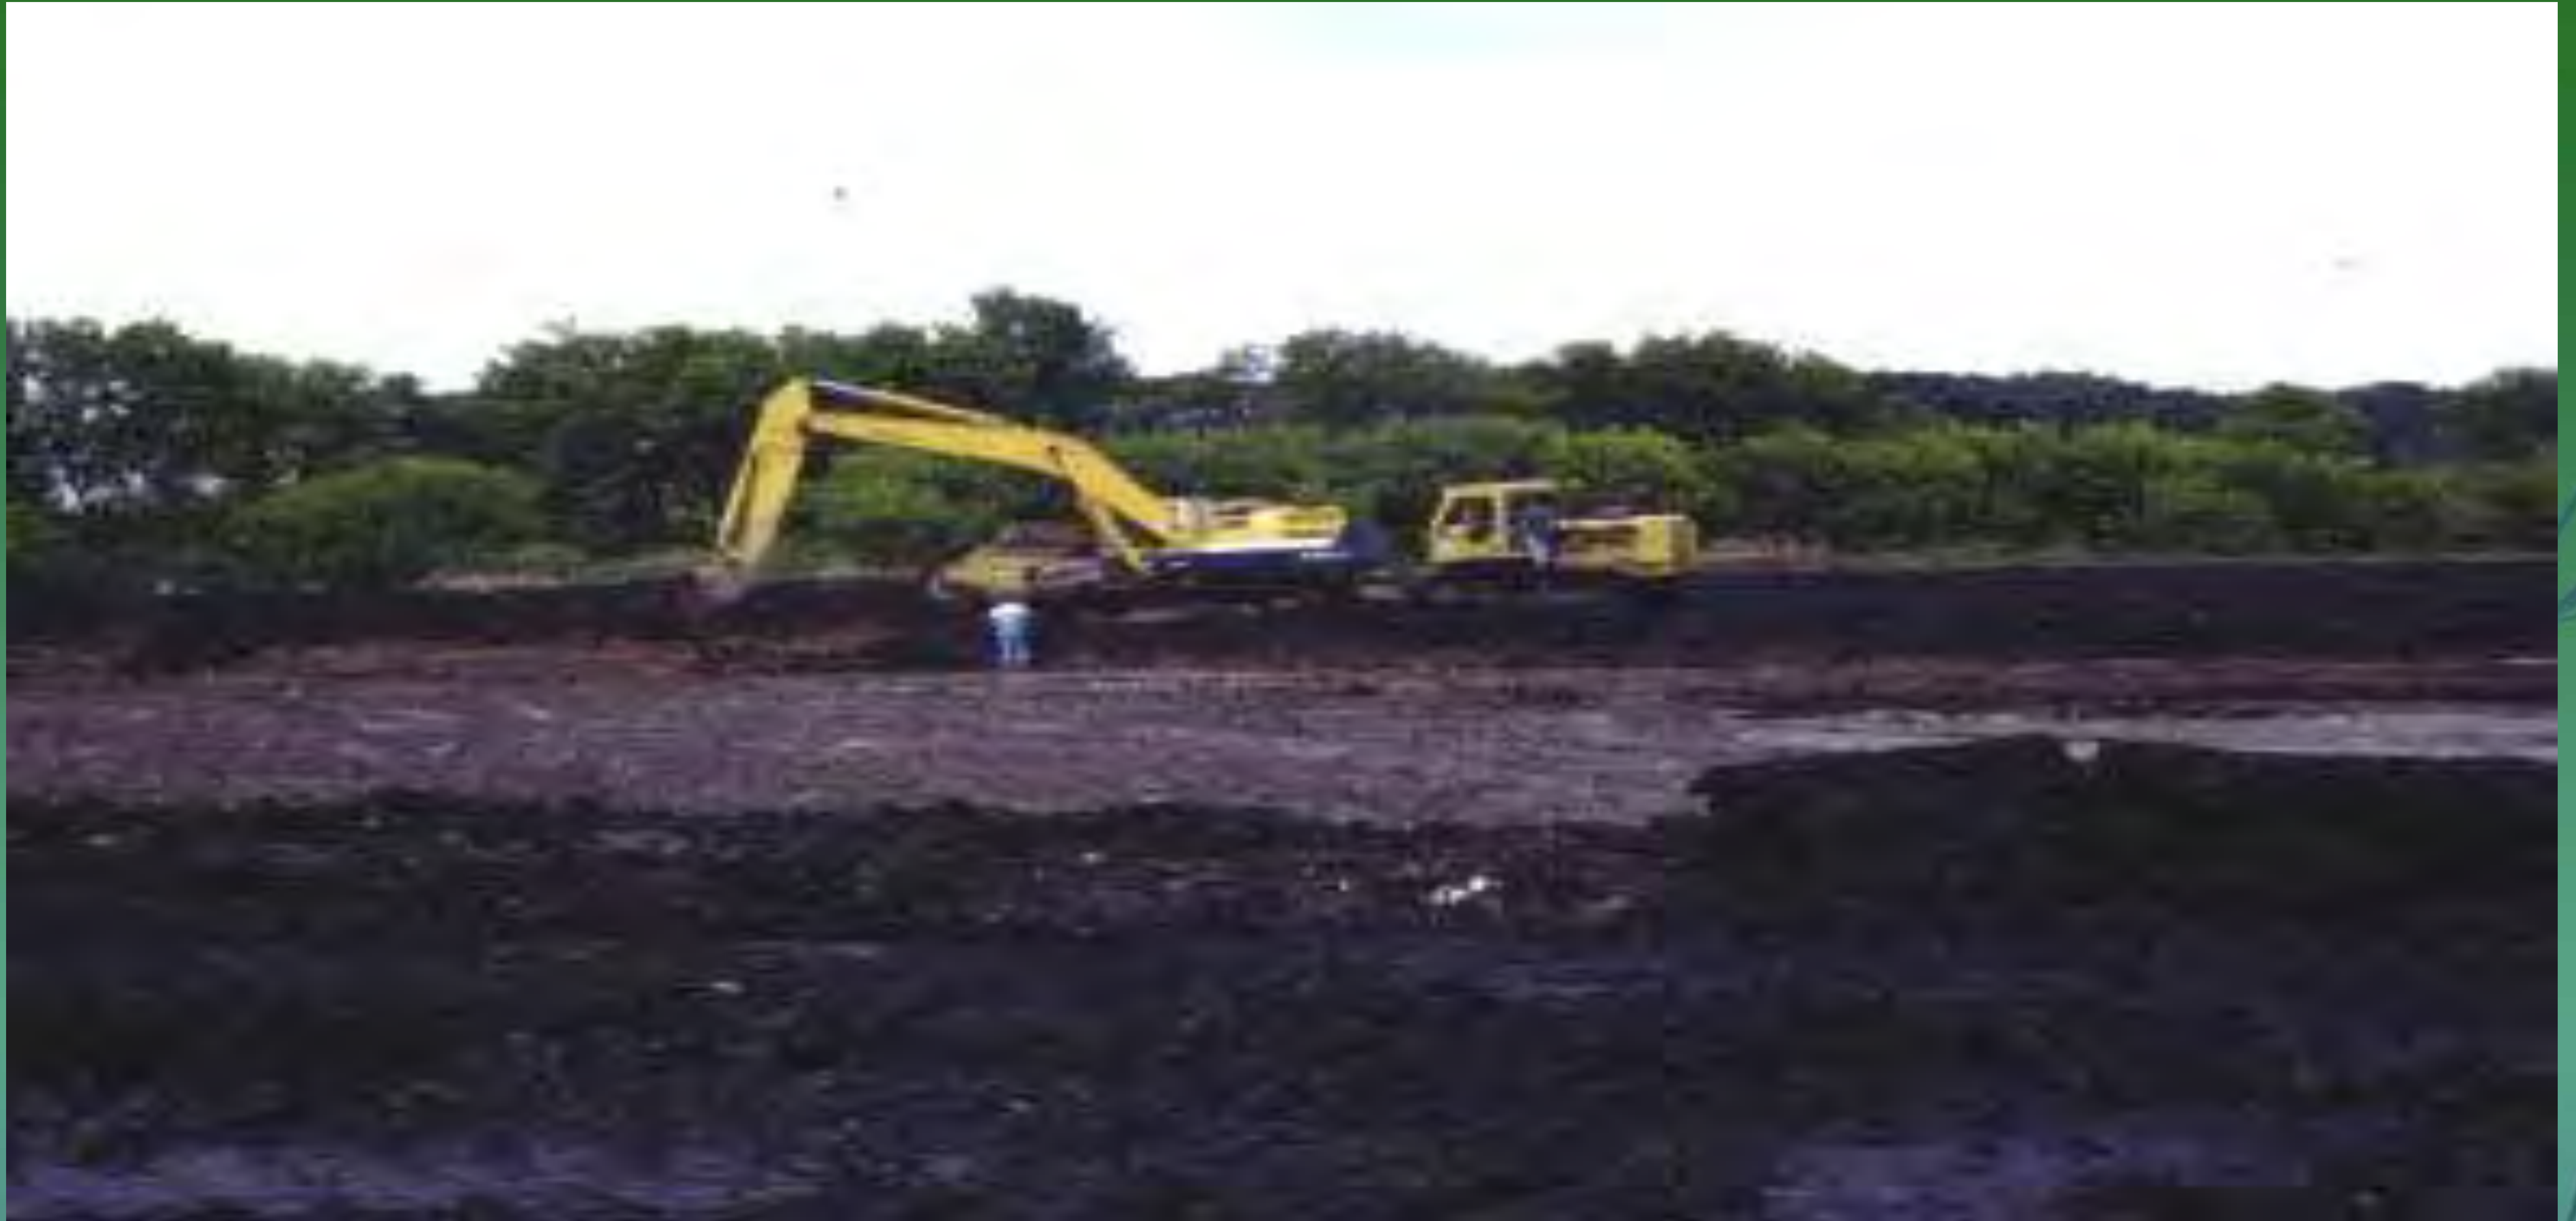
Excavating Swales, Disabling Tiles, Backfilling Ditches

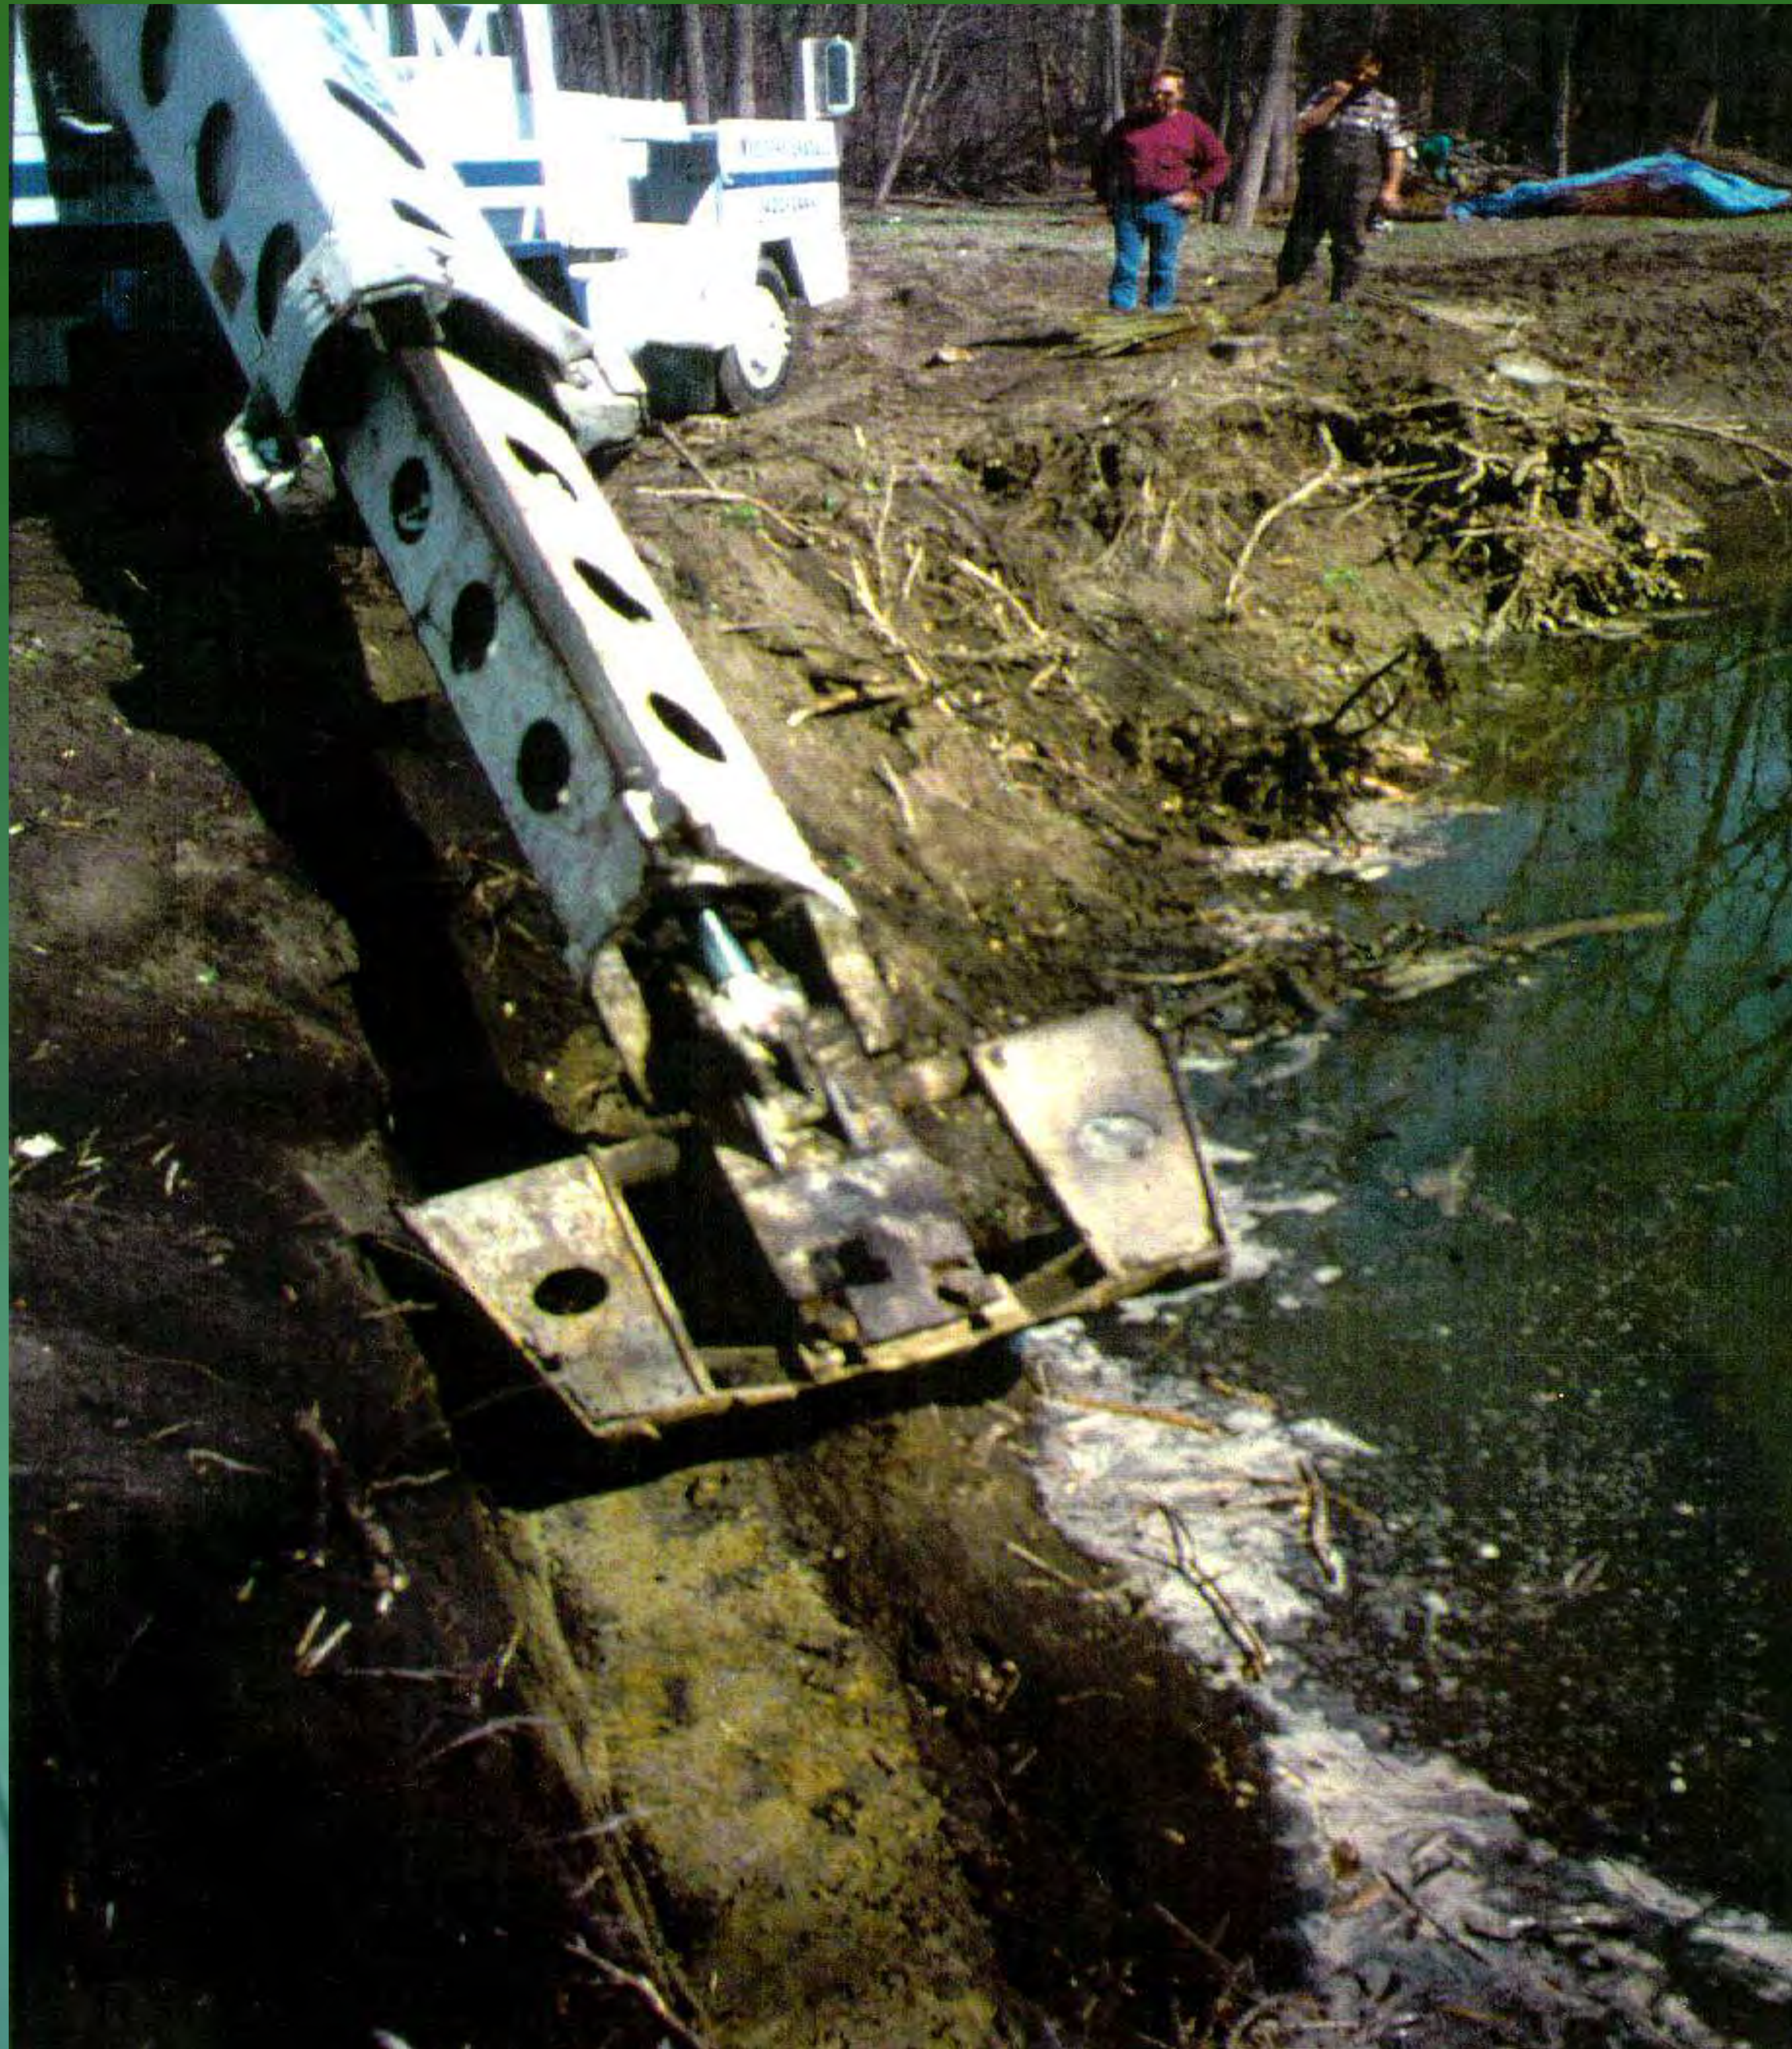
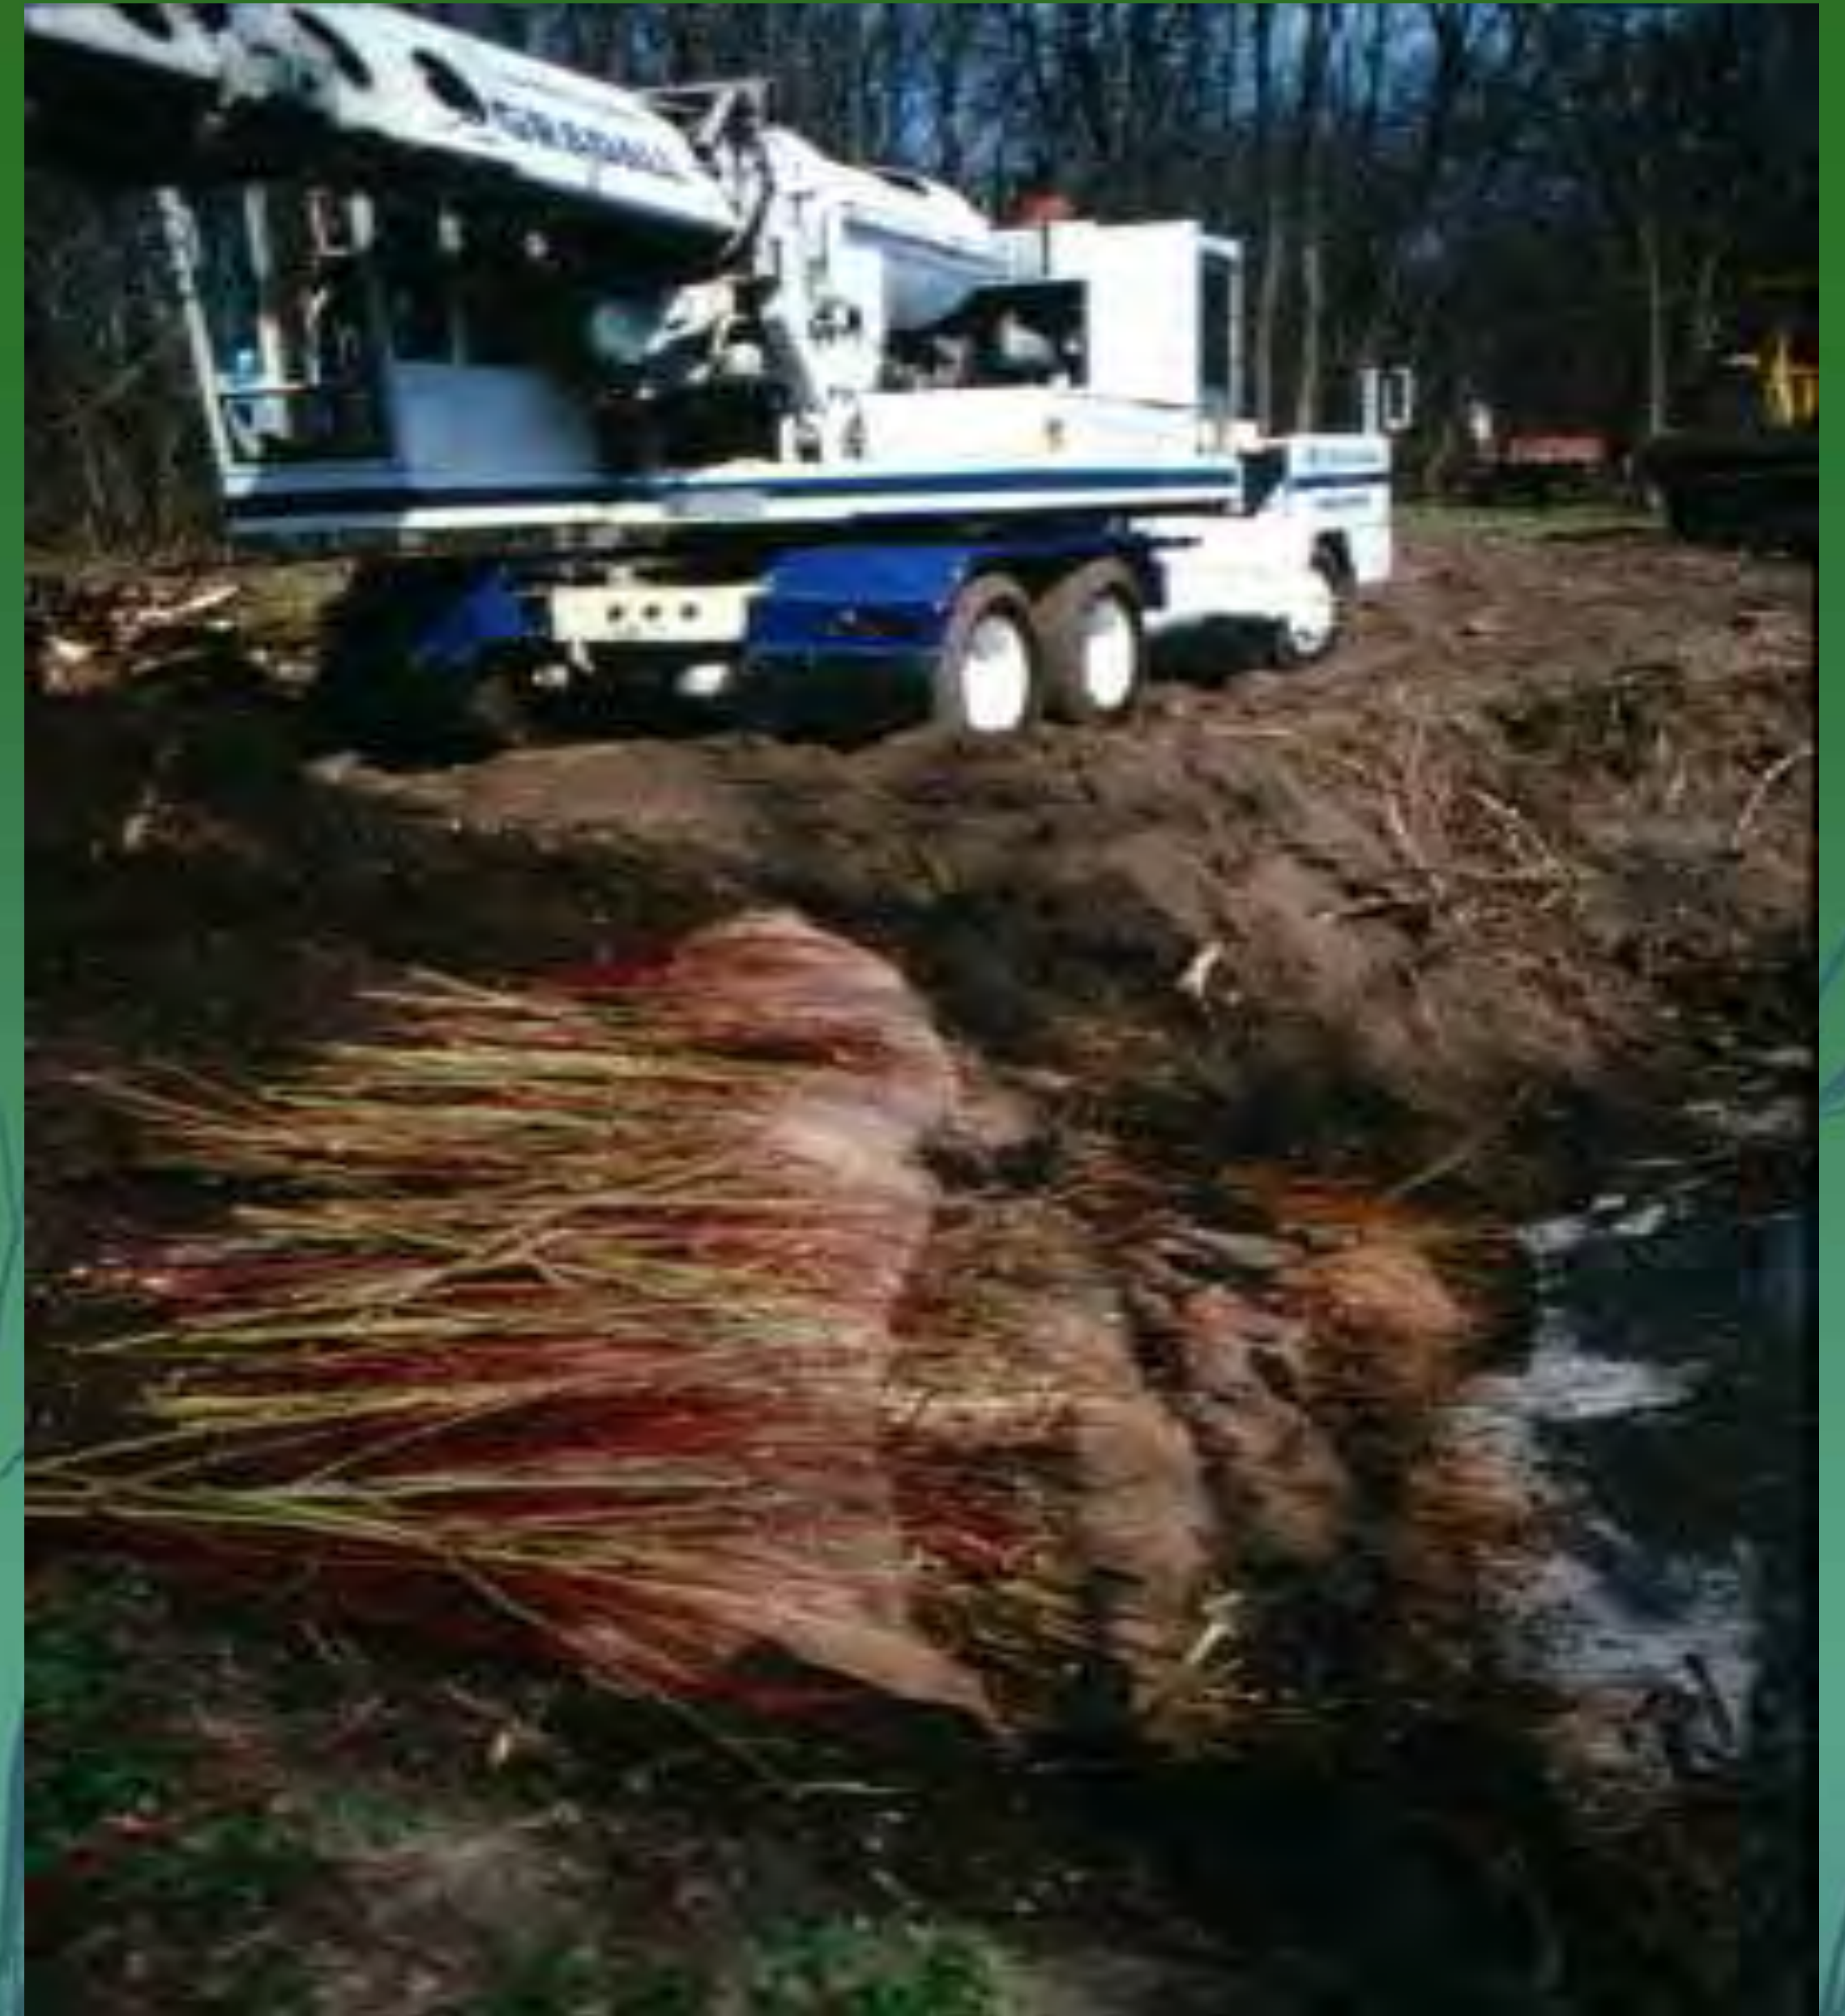
Soil BioEngineering of Degraded Channels

Brush Layering Technique

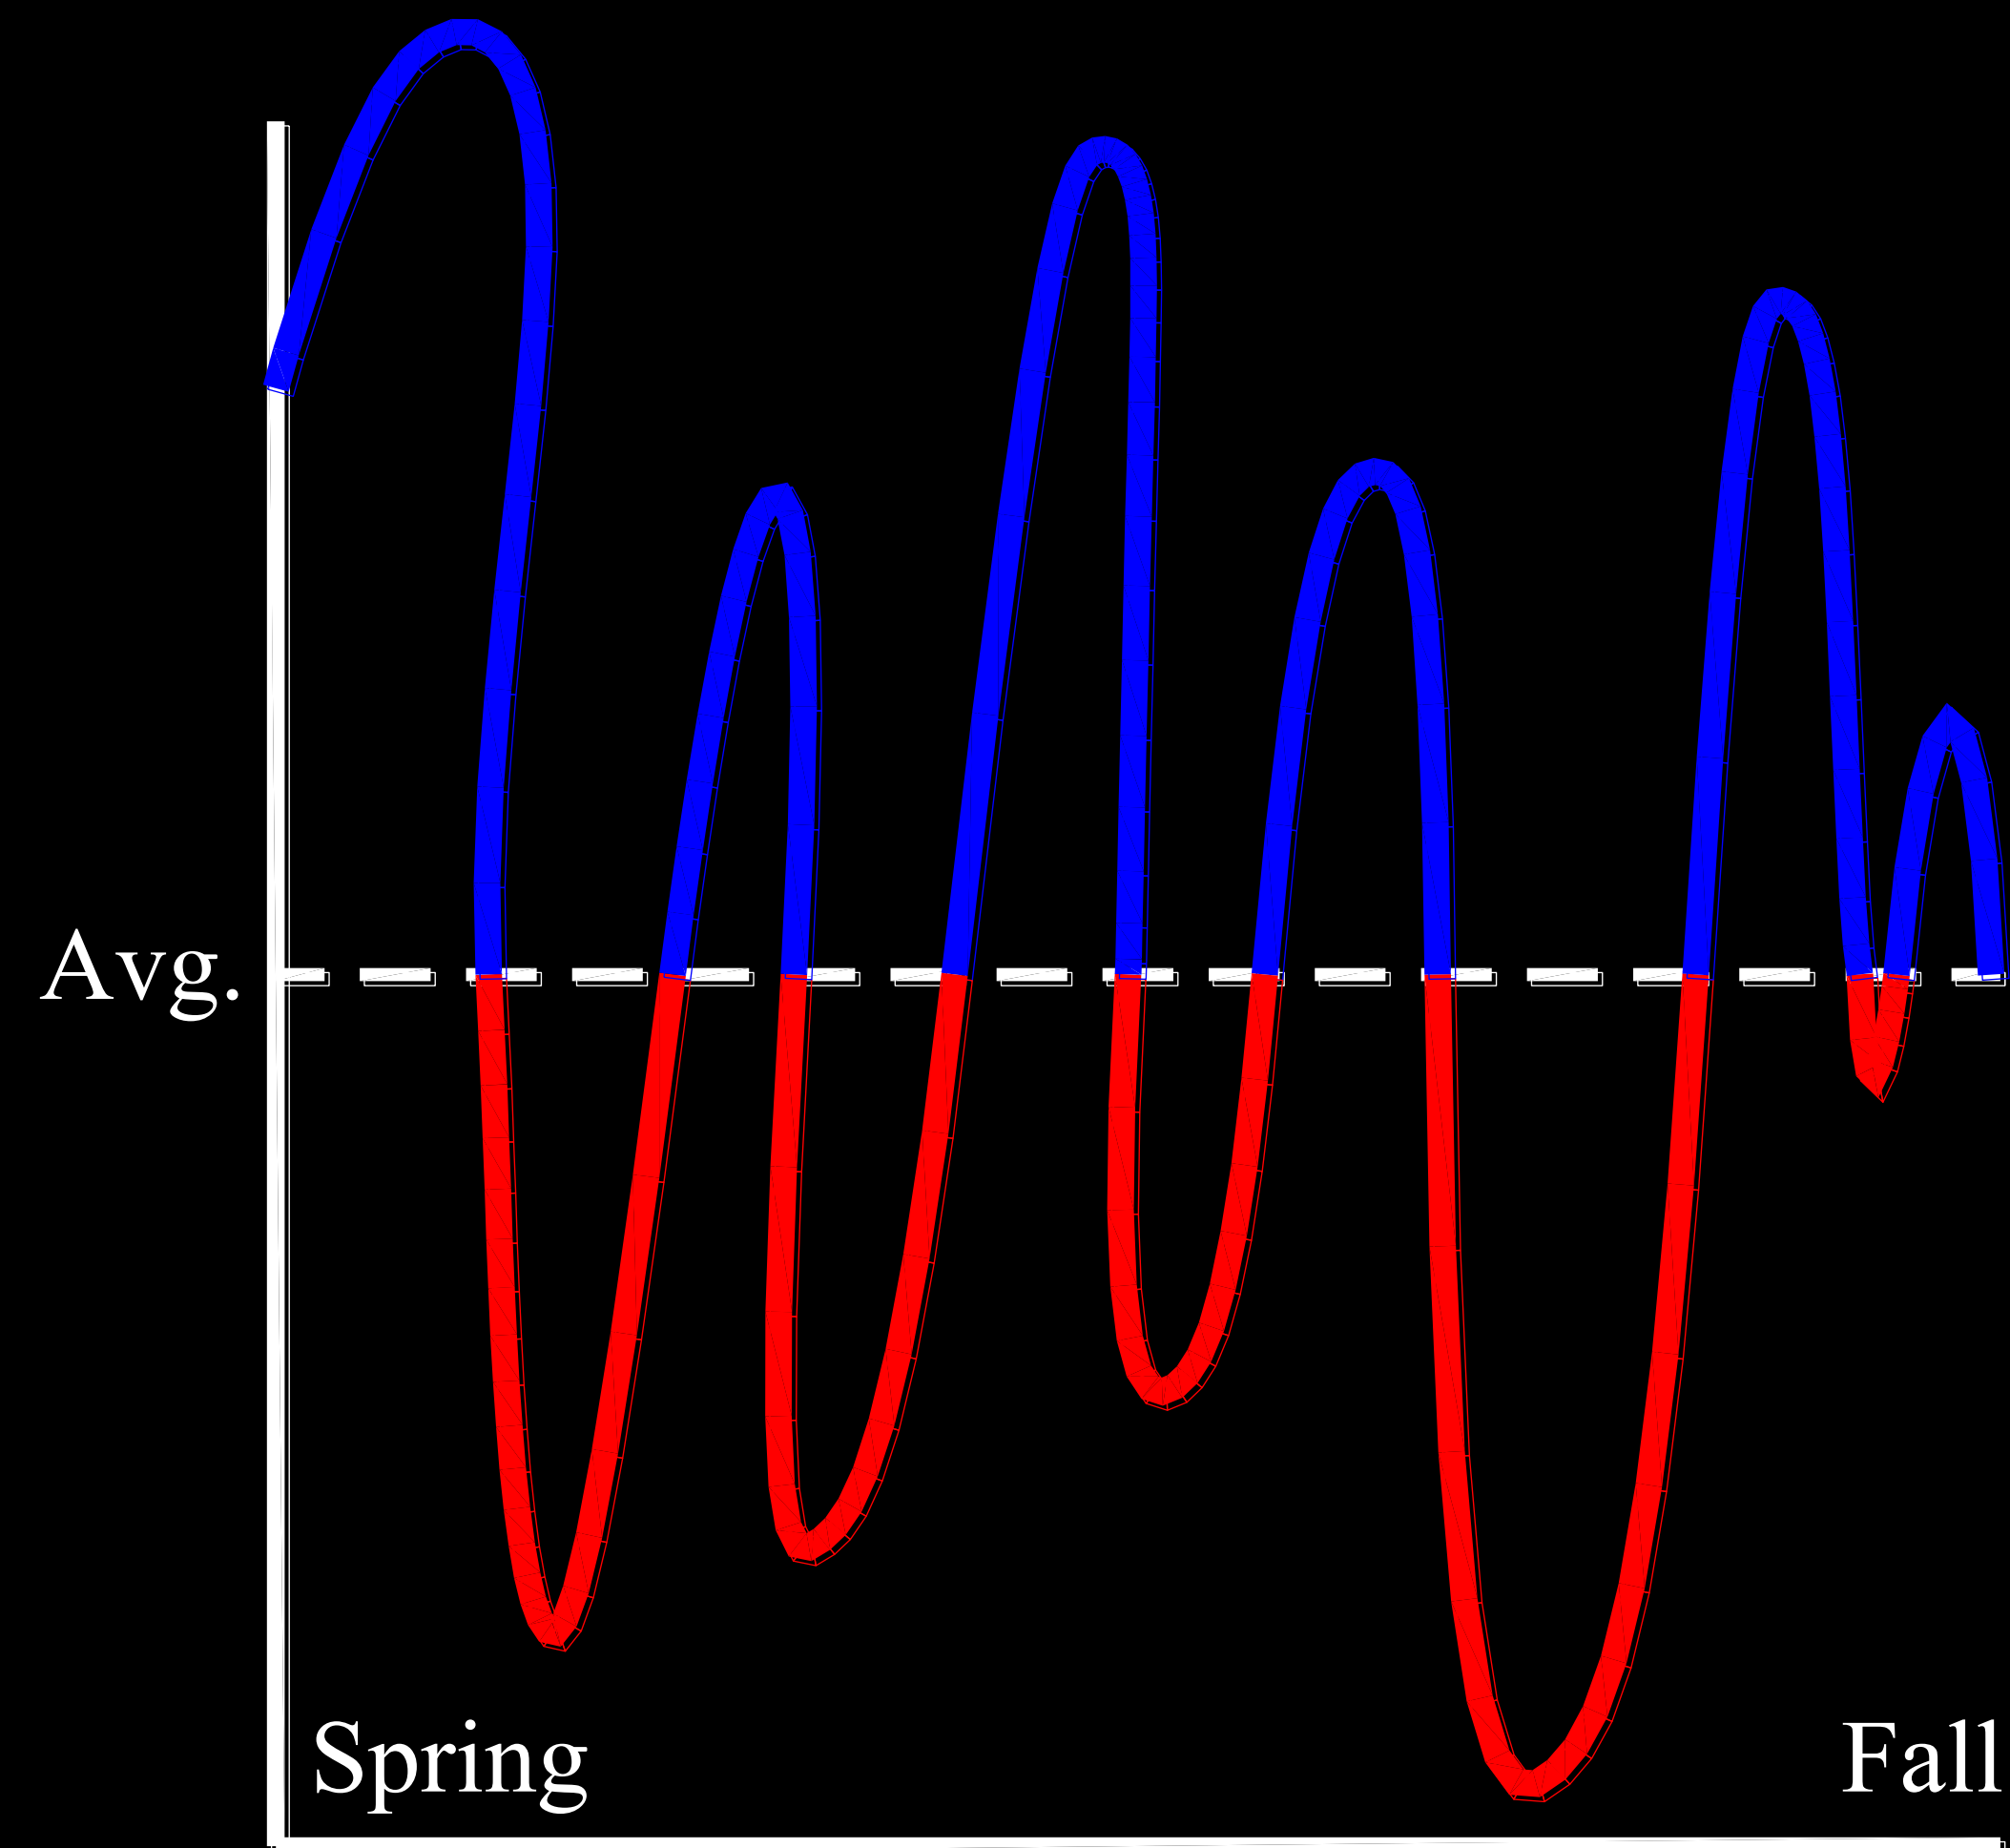
Engineering Approach to Hydrology

- * Unpredictable Swings in Water Levels
- * Creates Biological Instability
- * Promotes Habitats for Weeds and Poor Aesthetics
- * Promotes Poor Water Quality
