Ecosystems Past and Present:

An Introduction

Bringing the science of ecology to all land-use decisions

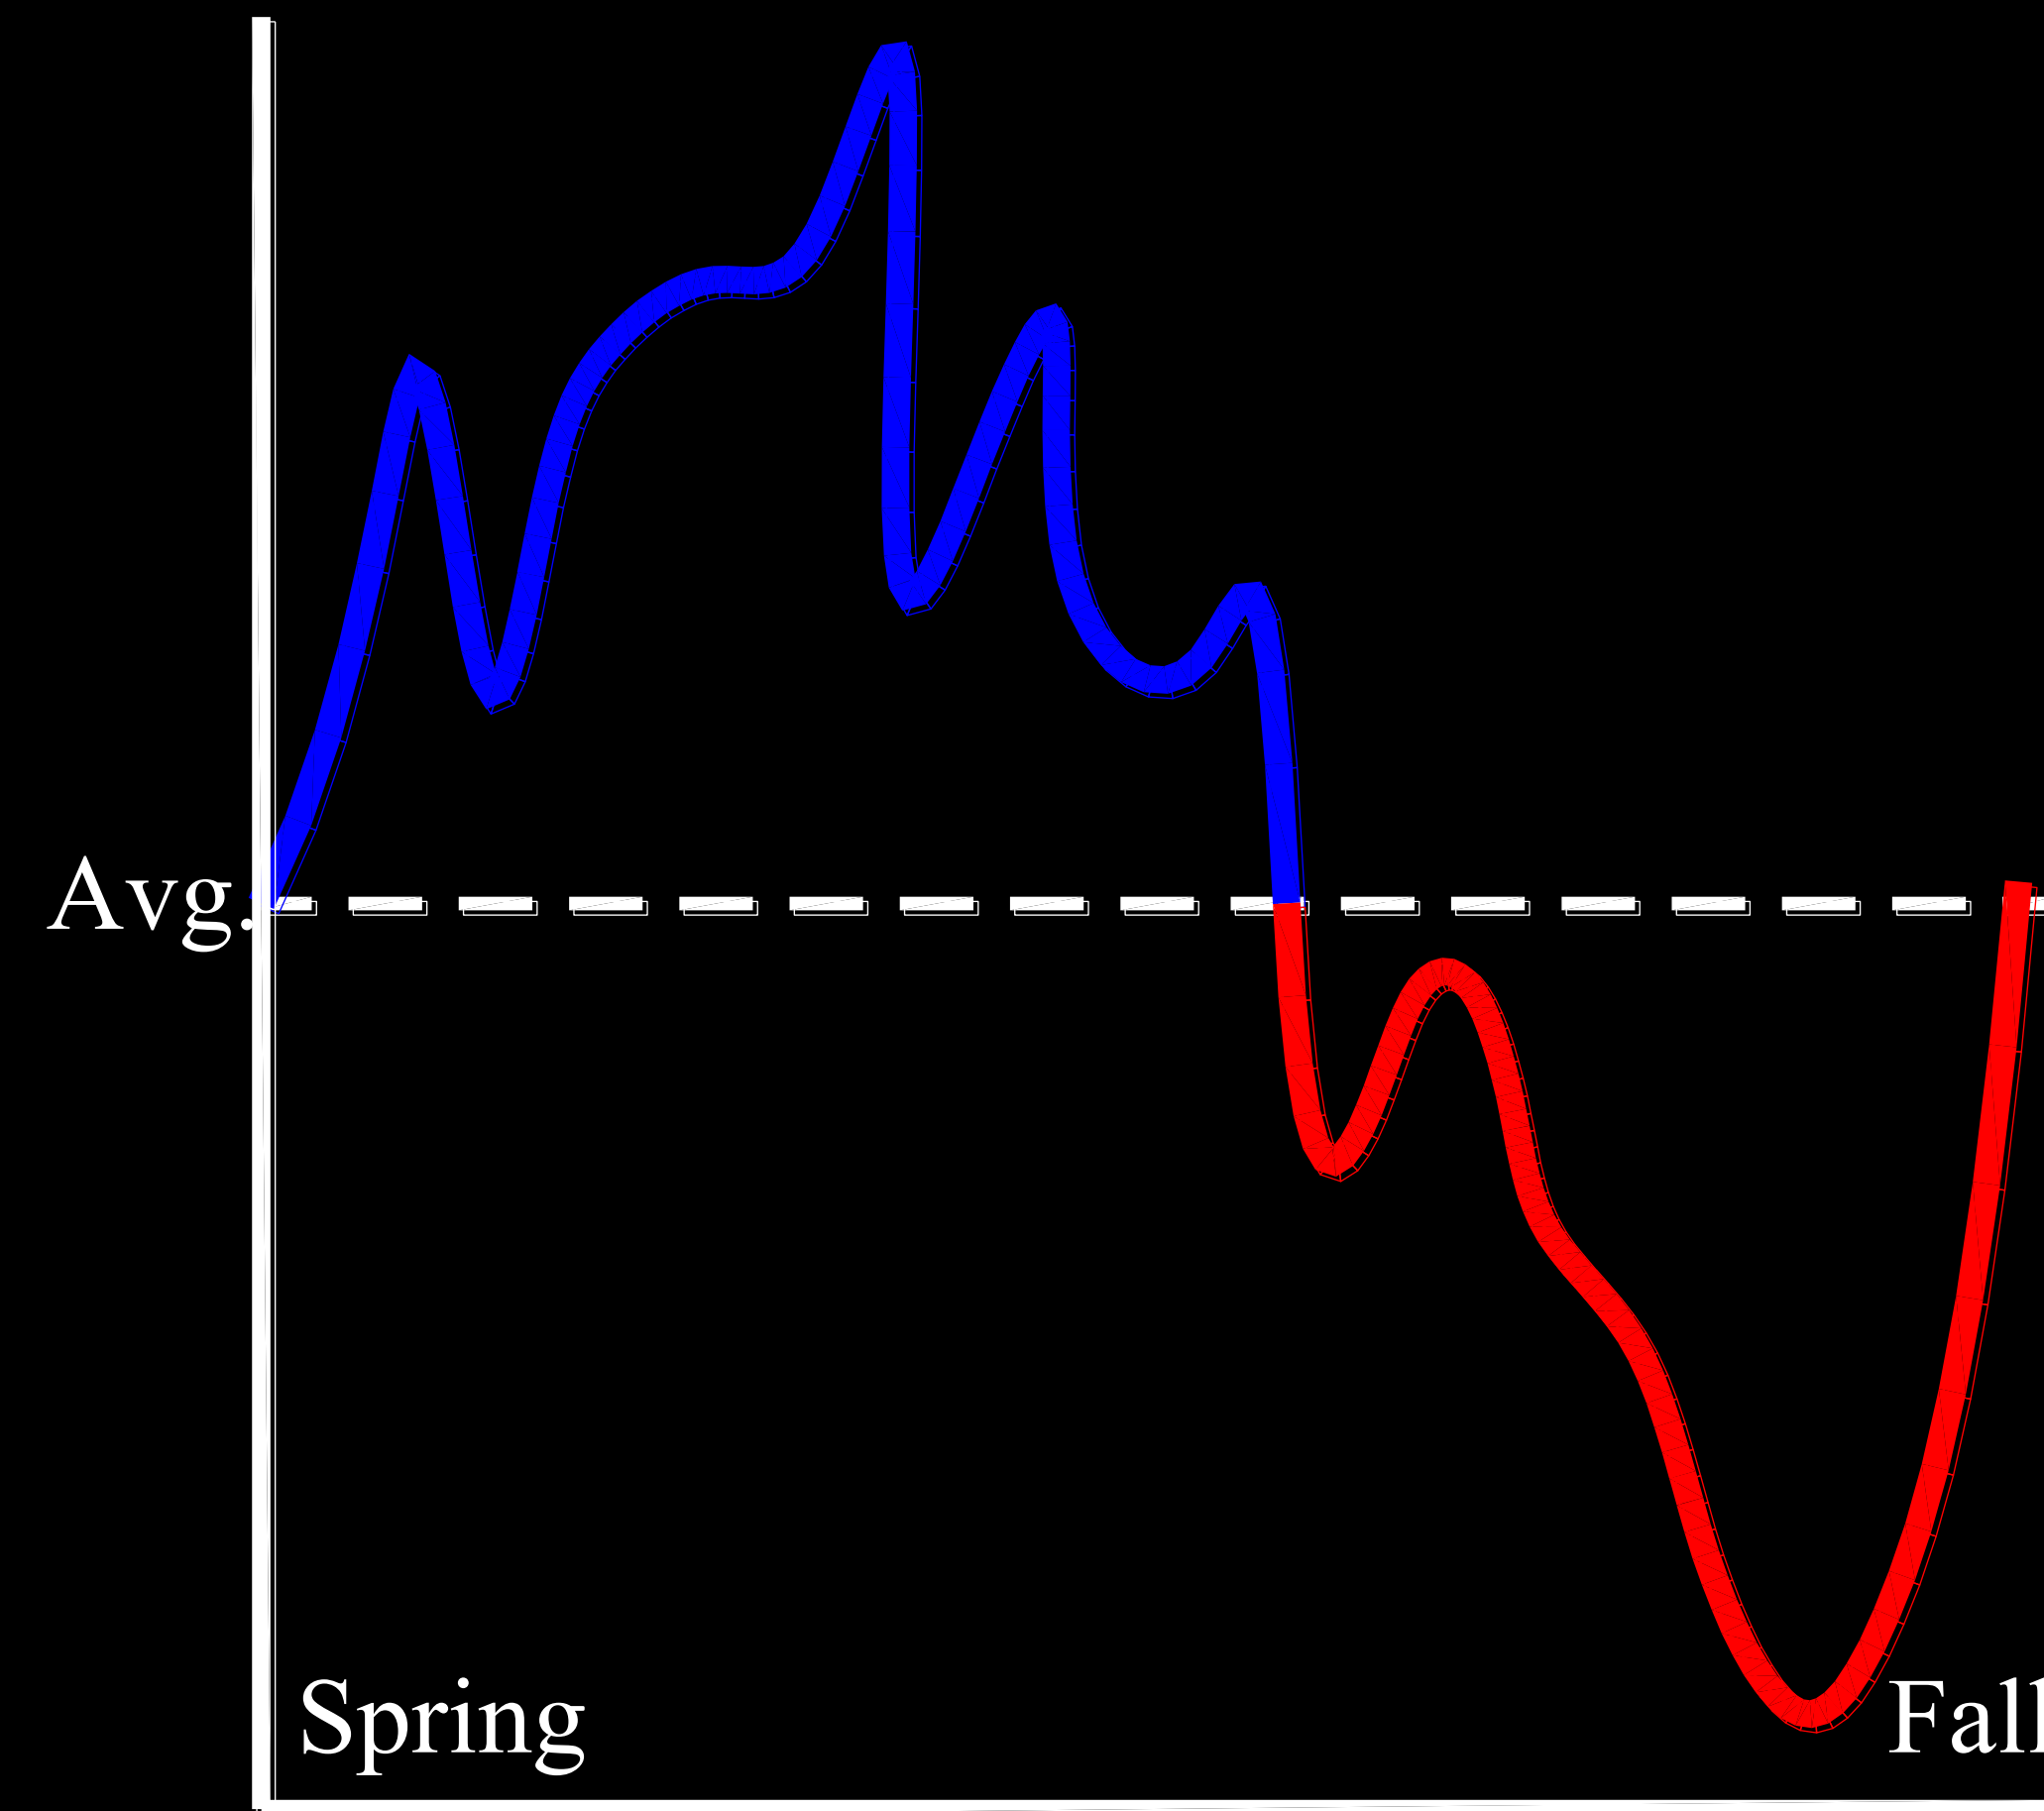
Ecologist Approach to Hydrology

- * Annual Seasonal High and Low
- * Predictable Hydraulics and Seasonal Trajectory
- * Promotes Habitat for Stable yet Dynamic Plant Communities (Diversity of Plants and Animals)

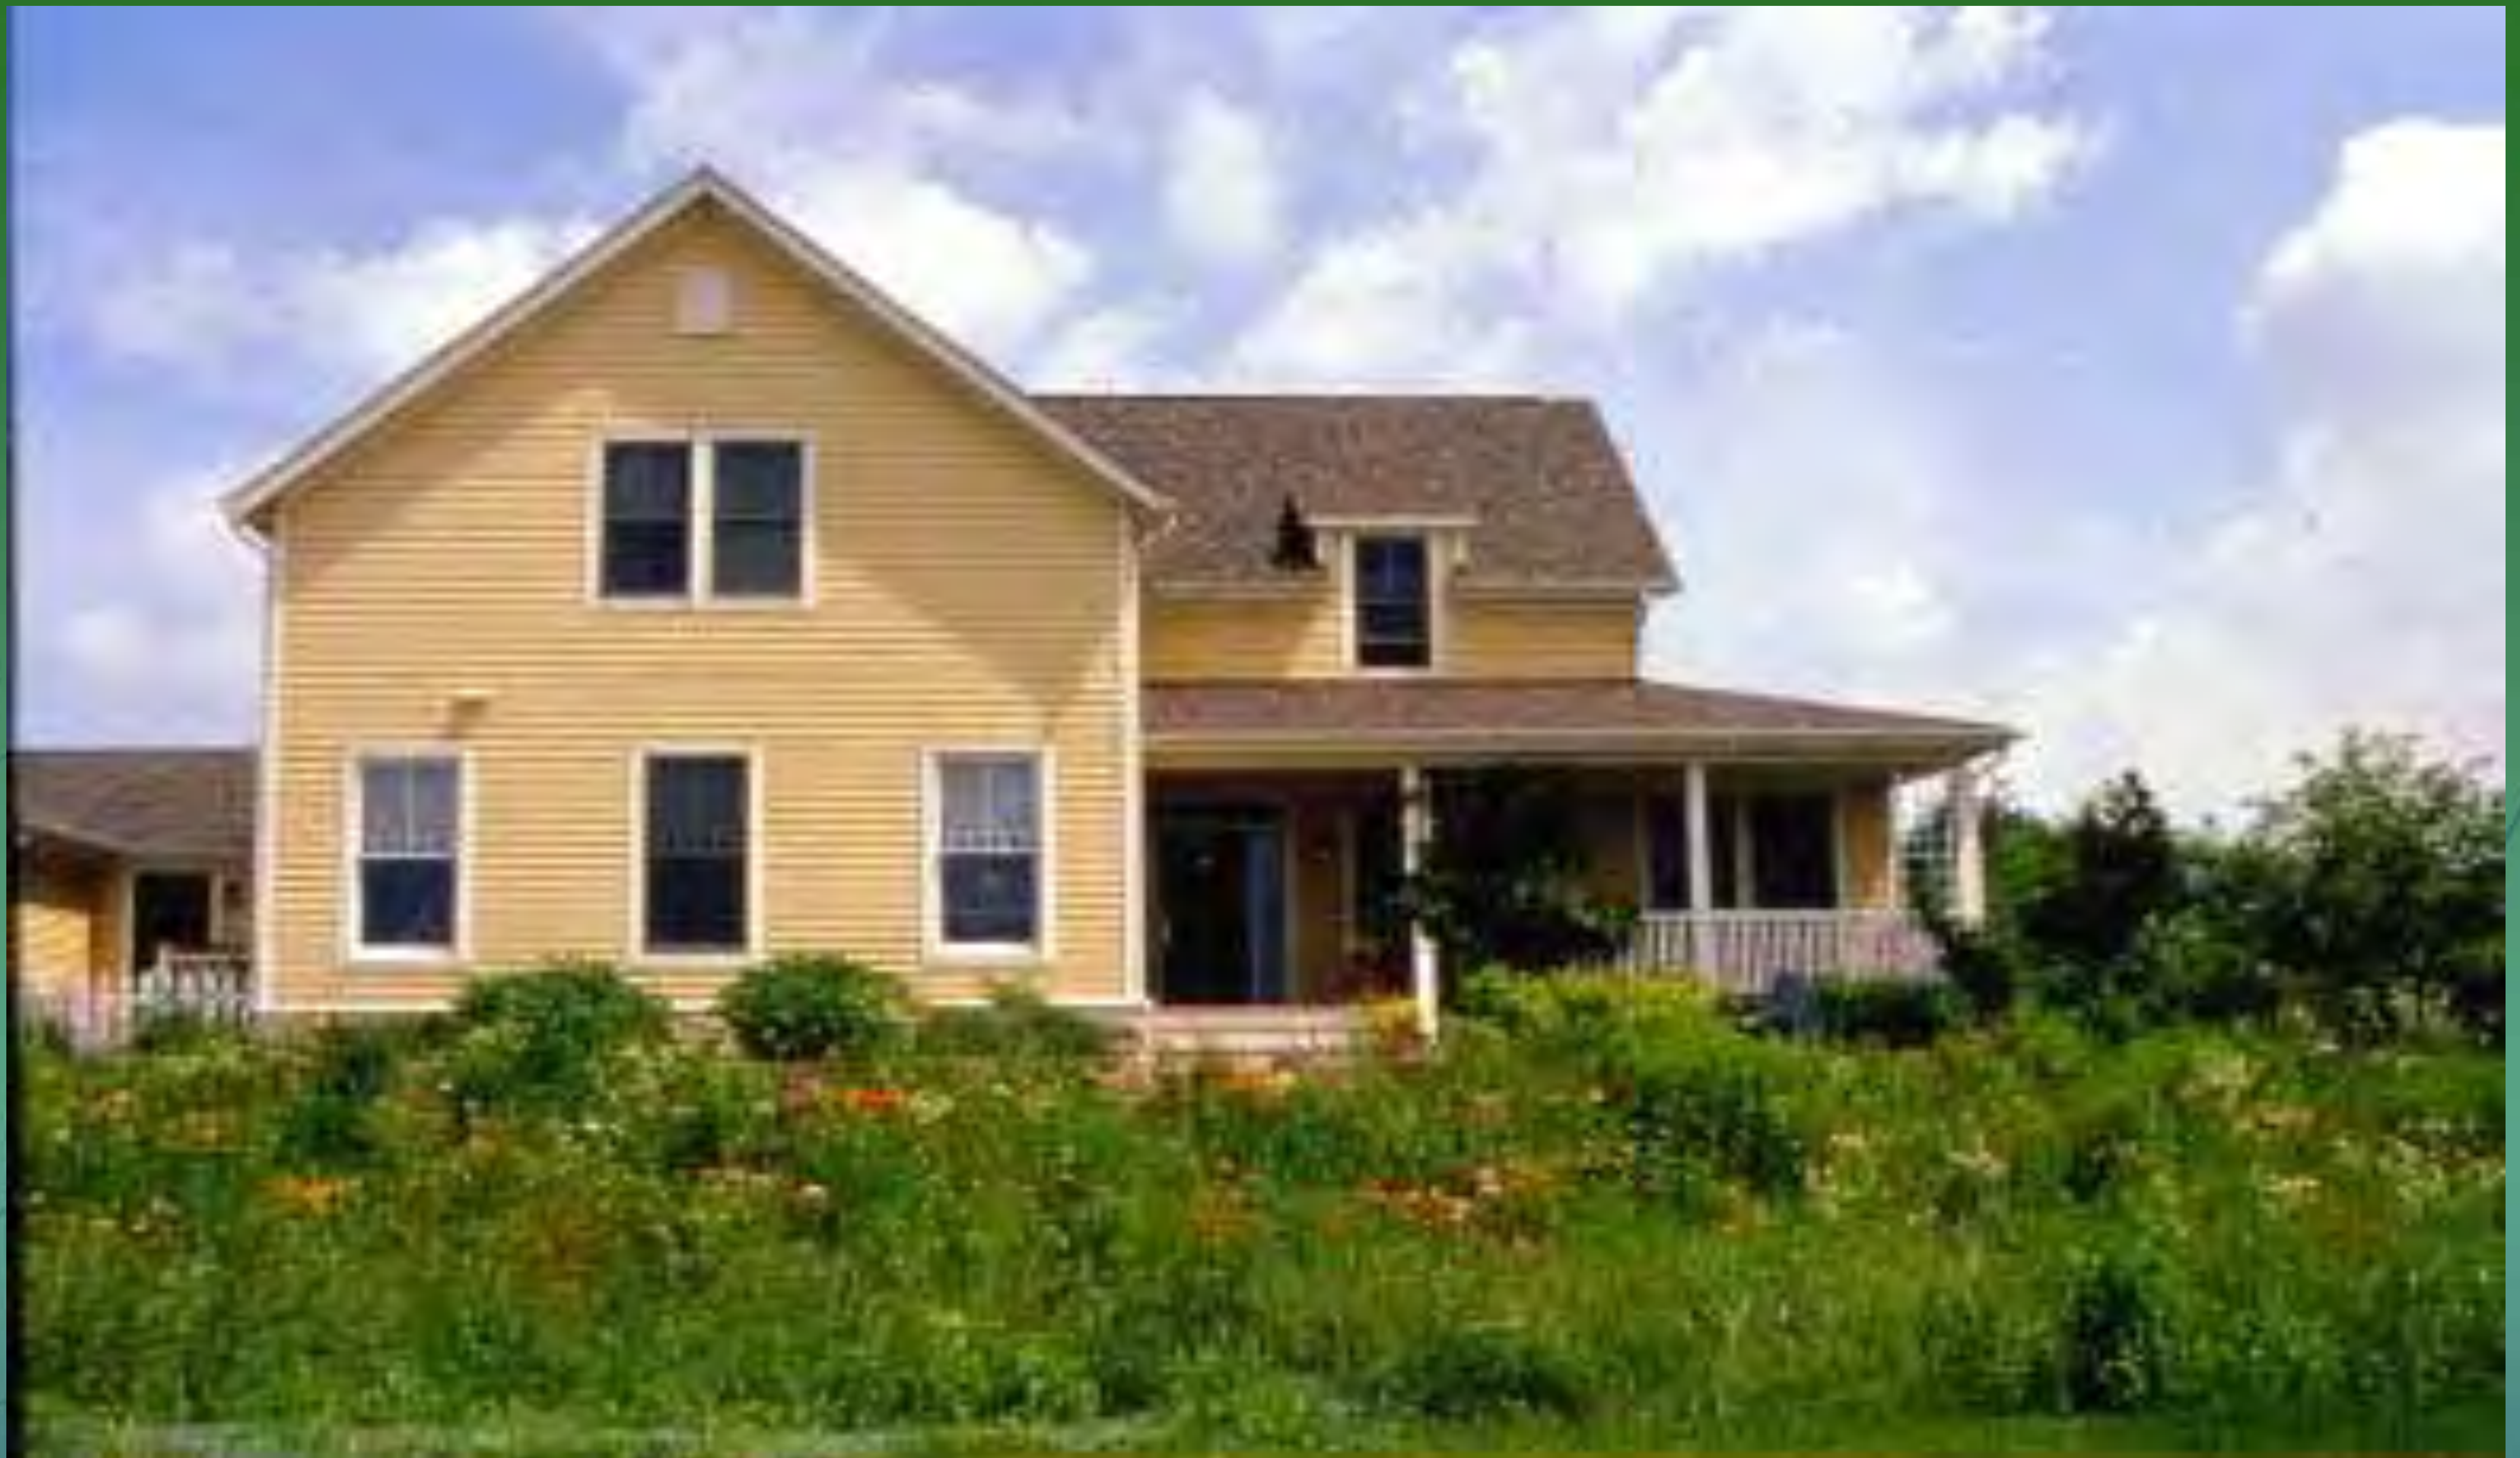
Hydrograph Comparison

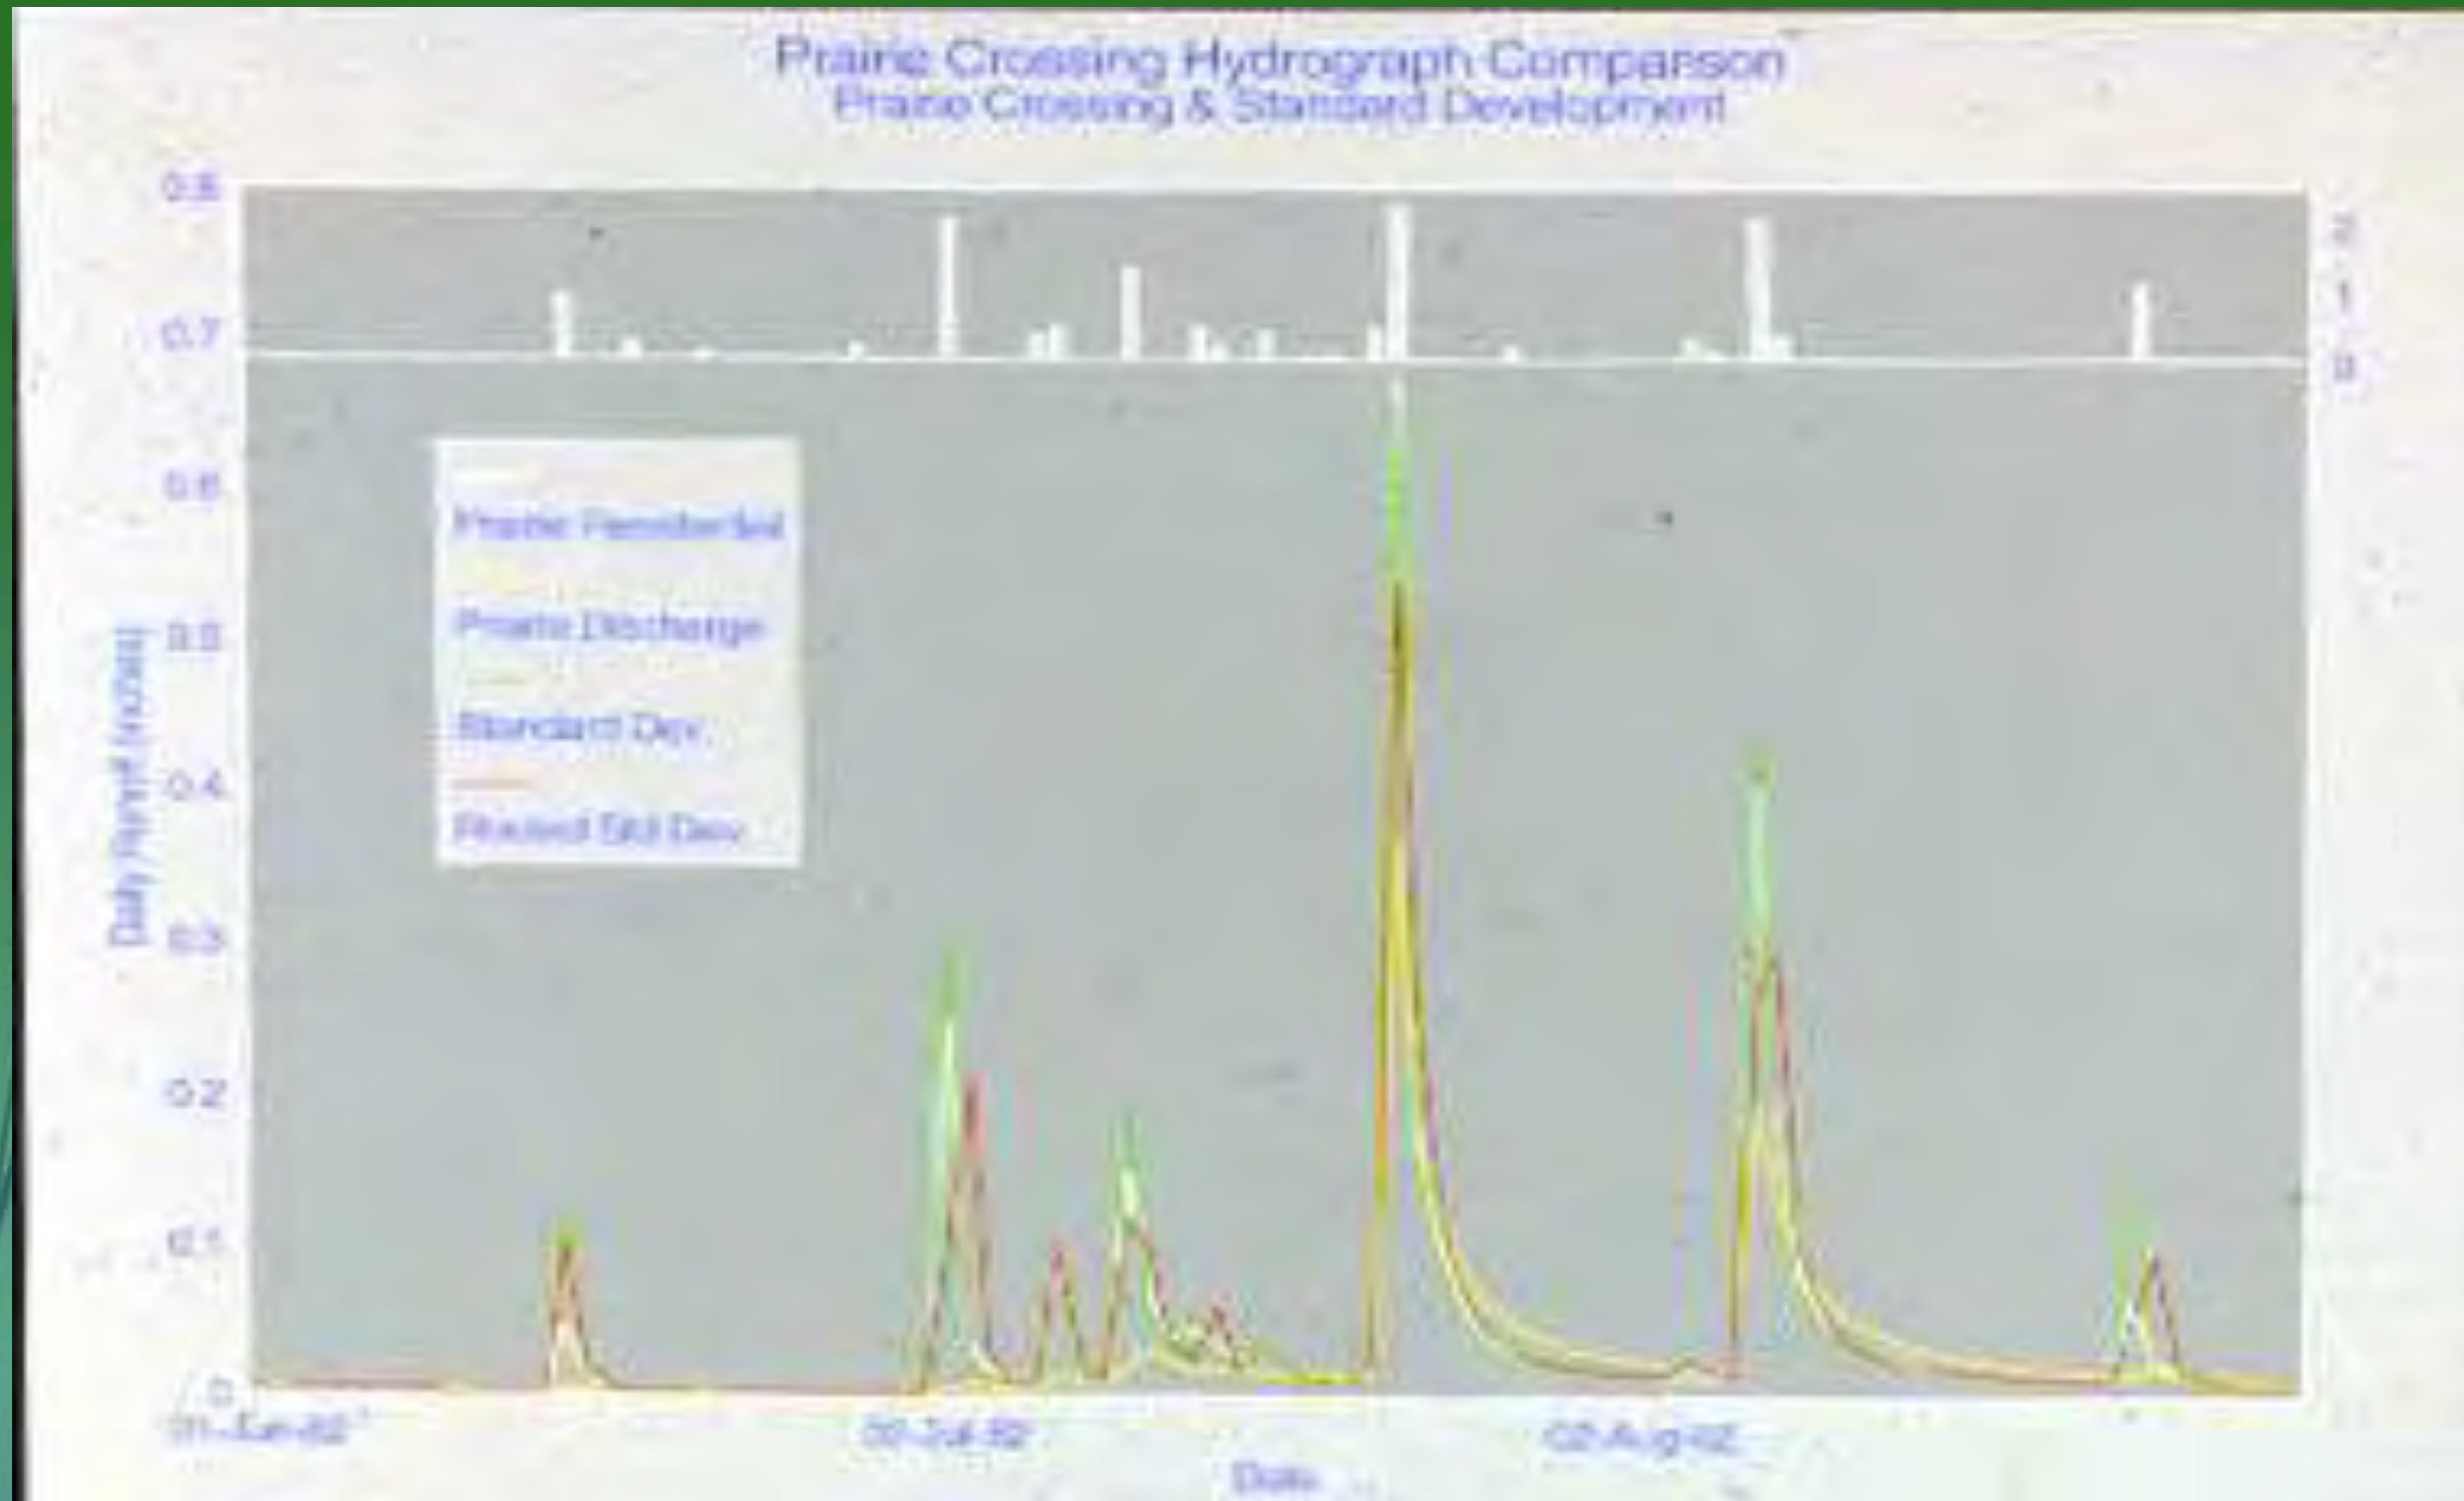
Prairie Crossing - Lake Water Quality
