The Association of State Wetland Managers Presents:
**Improving Wetland Restoration Success
2014 — 2015 Webinar Series**

***Atlantic Coast Coastal Marshes
& Mangrove Restoration***

***Presenters: Roy R. "Robin" Lewis, III,
John Teal, James Turek and Joseph Shisler***

Restoration and Creation of Atlantic Coast Tidal Marshes and Mangrove Forests: It Looks Easy But It is Not!

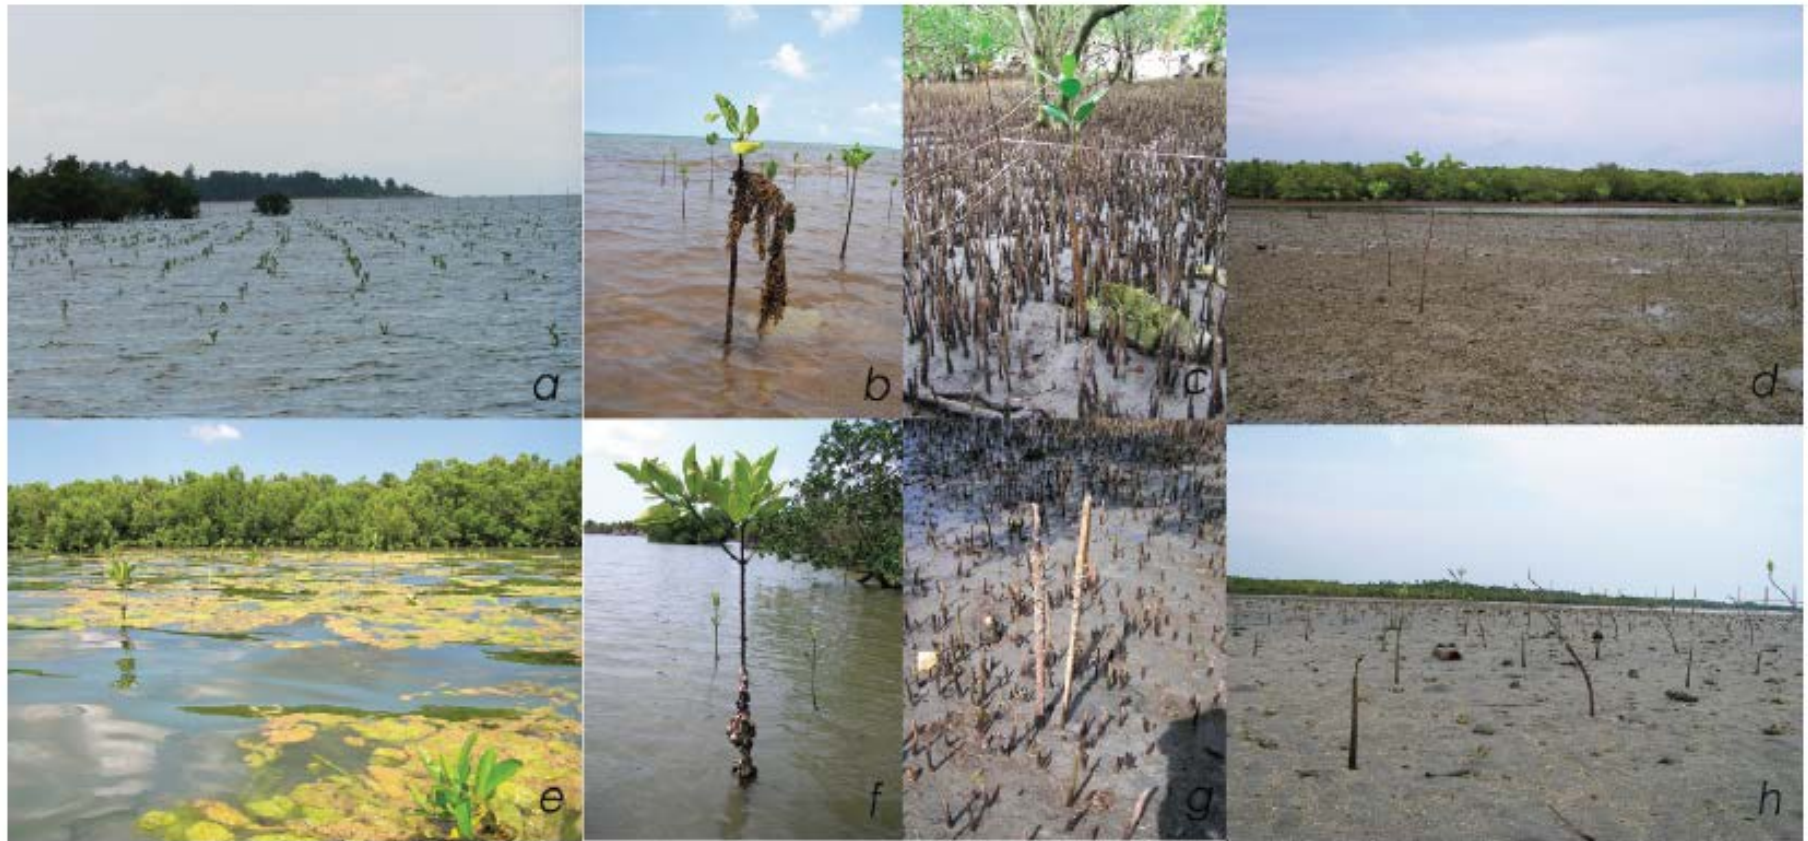
Figure 2. Some examples of the less successful mangrove enhancement initiatives in the Philippines, mainly planting *Rhizophora* at the seafronts: (a) under a prolonged period of immersion, *Rhizophora* seedlings planted at the lower intertidal zone may “drown,” causing massive mortalities in Tayabas Bay (16, pers. obs.); (b and e) macroalgae and other debris may cause defoliation of the broad-leaved *Rhizophora*; (c and g) planting between pneumatophores (c) of *Sonneratia* and aided by bamboo stakes (g) did not prevent many *Rhizophora* seedlings from dying (g; i.e., <50 of the ~1000 seedlings planted survived; Agdangan, Quezon); (d and h) part of 10-ha mangrove plantation (carbon-sink) effort in which *Rhizophora* seedlings mostly (i.e., >95% of the seedlings within sampling plots) died after only about 9 months, apparently because of the mechanical stress of wave action and substrate erosion; and (f) seedling stems serving as substrates for oyster colonization.

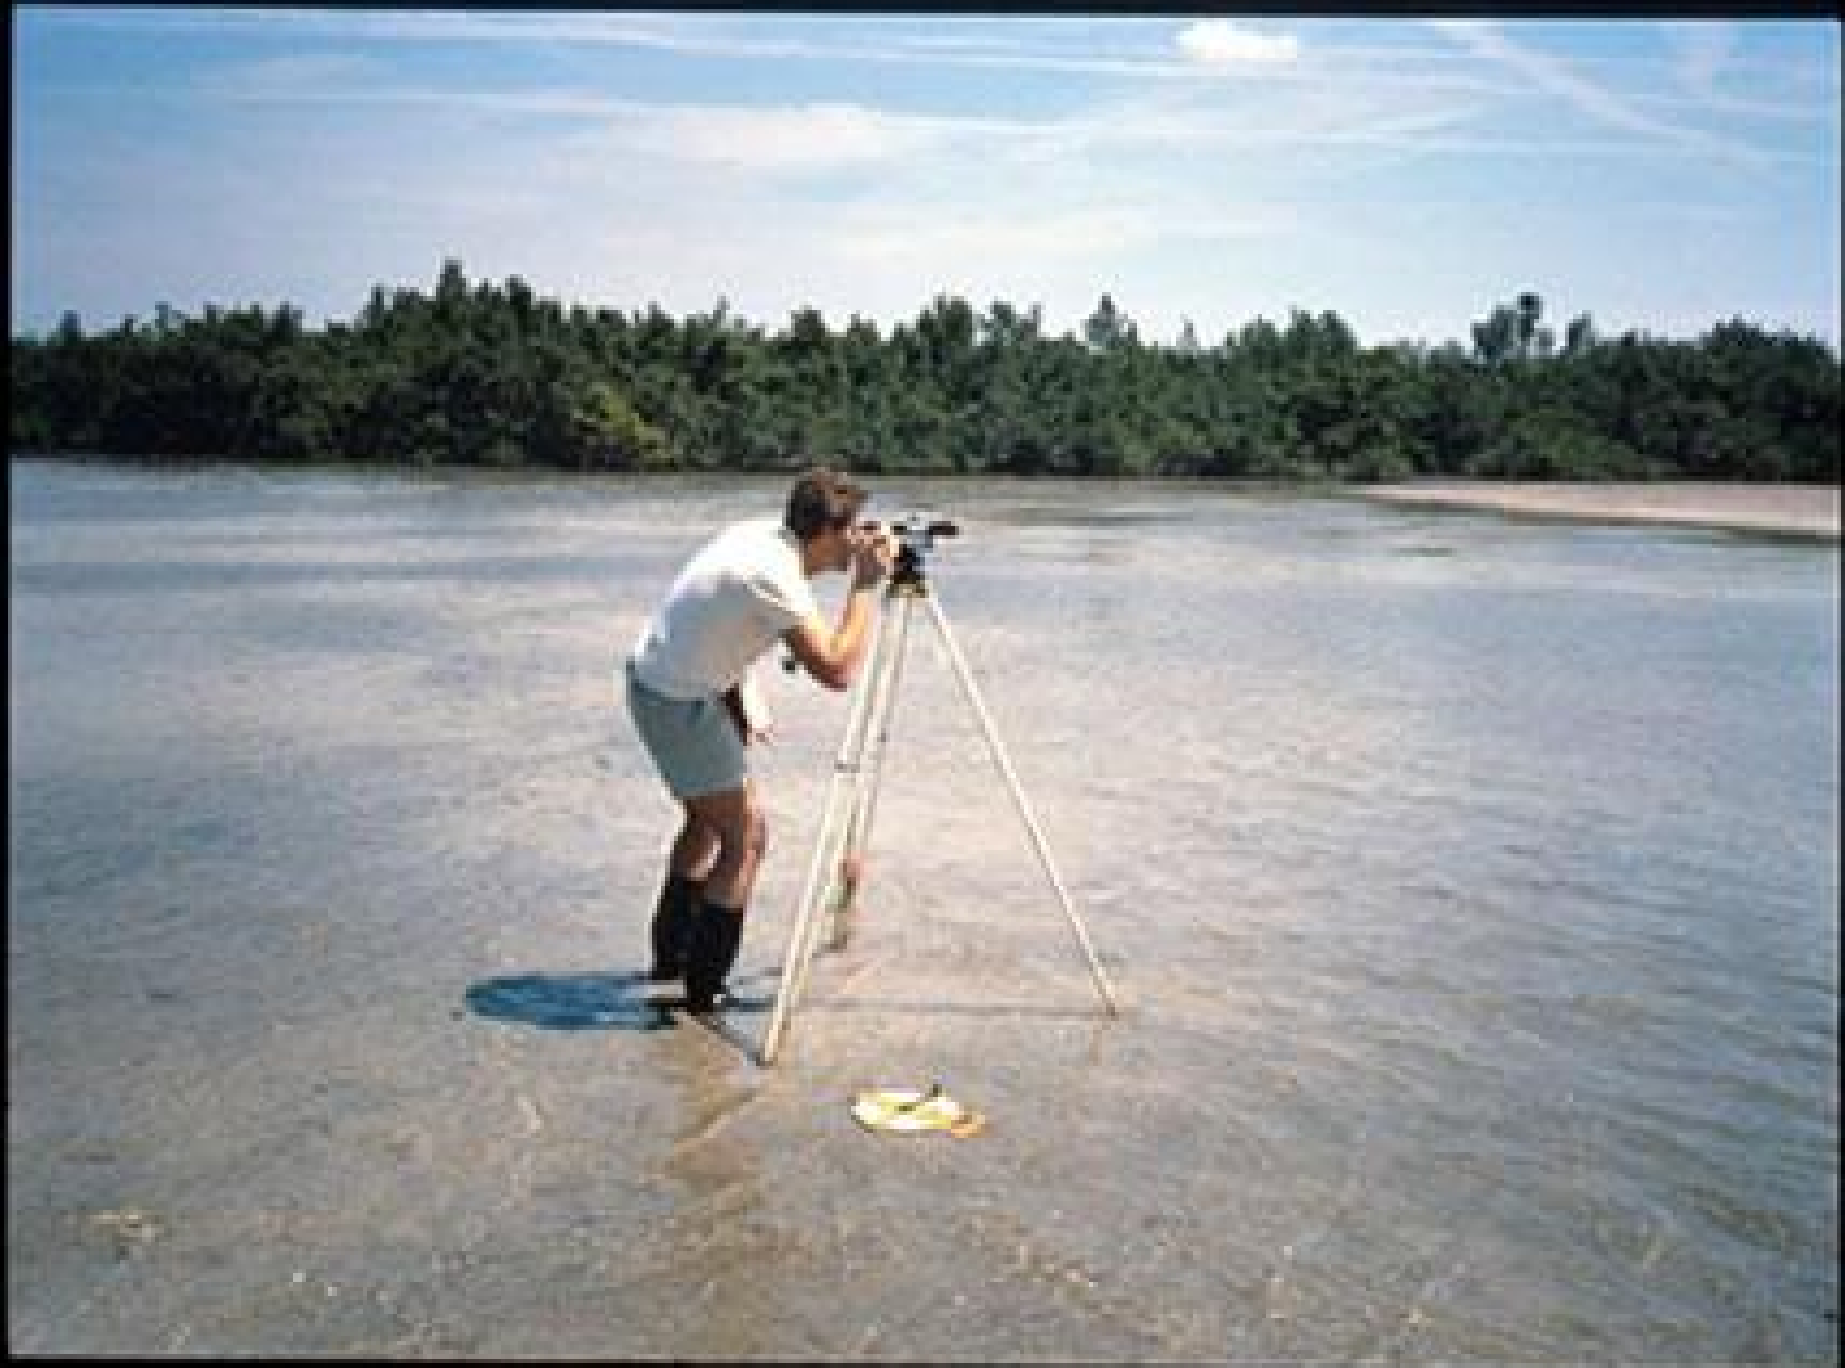
PLANT ZONATION – LOW ENERGY BAY SHORELINE

AG = AVICENNIA	JR = JUNCUS	PV = PASPALUM
BF = BORRICHIA	LR = LAGUNCULARIA	RM = RHIZOPHORA
BH = BACCHARIS	MC = MYRICA	SV = SALICORNIA
FC = FIMBRISTYLIS	ML = MONANTHOCHLOE	SA = SPARTINA
H = HALODULE	TH = THALASSIA

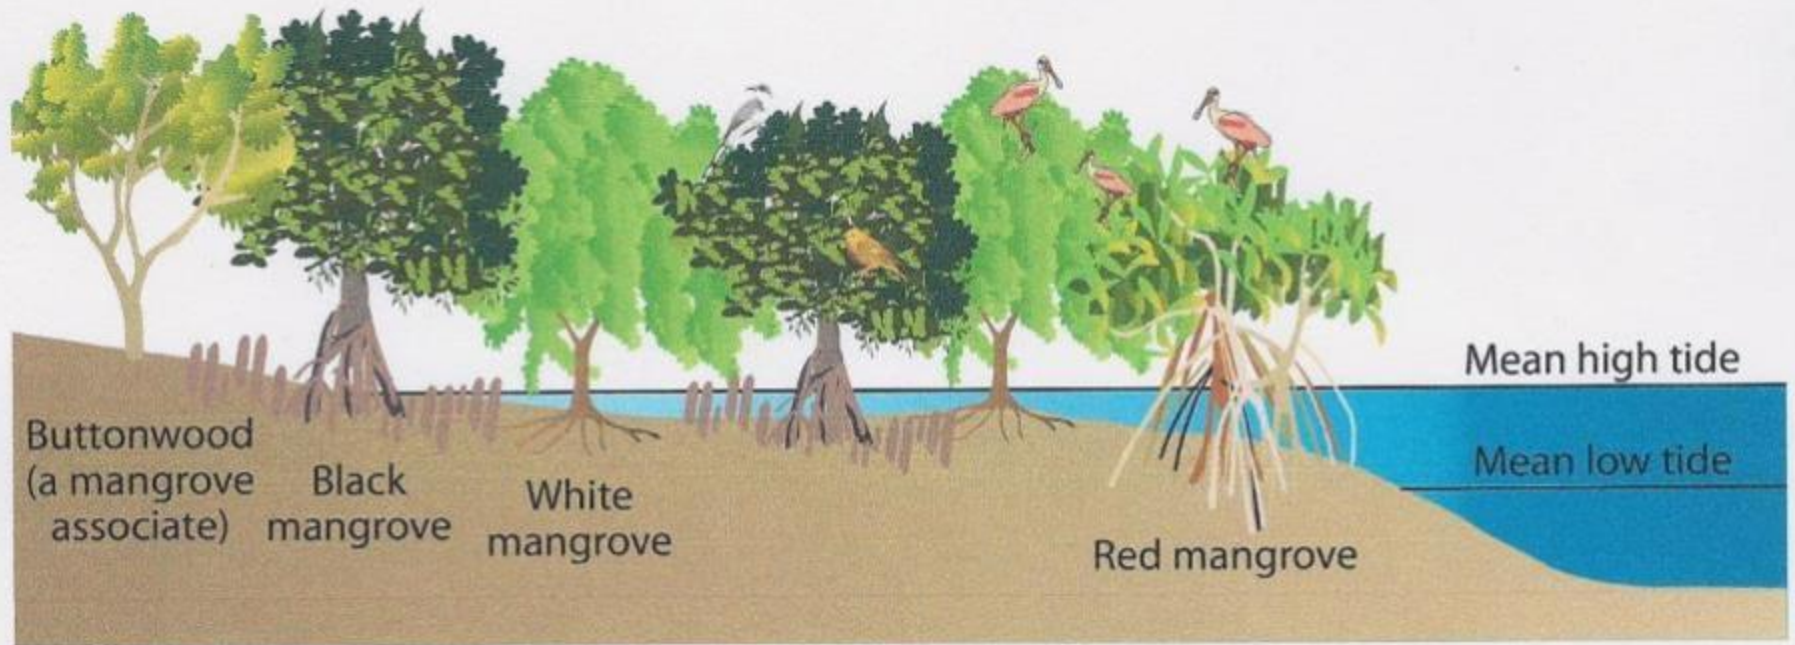
Mangrove Zonation in South Florida from Kruczynski and Fletcher 2012

The three dominant mangrove species found in south Florida are the red, black, and white mangrove. Buttonwood is a mangrove associate that is often found at the landward margin of mangrove communities.

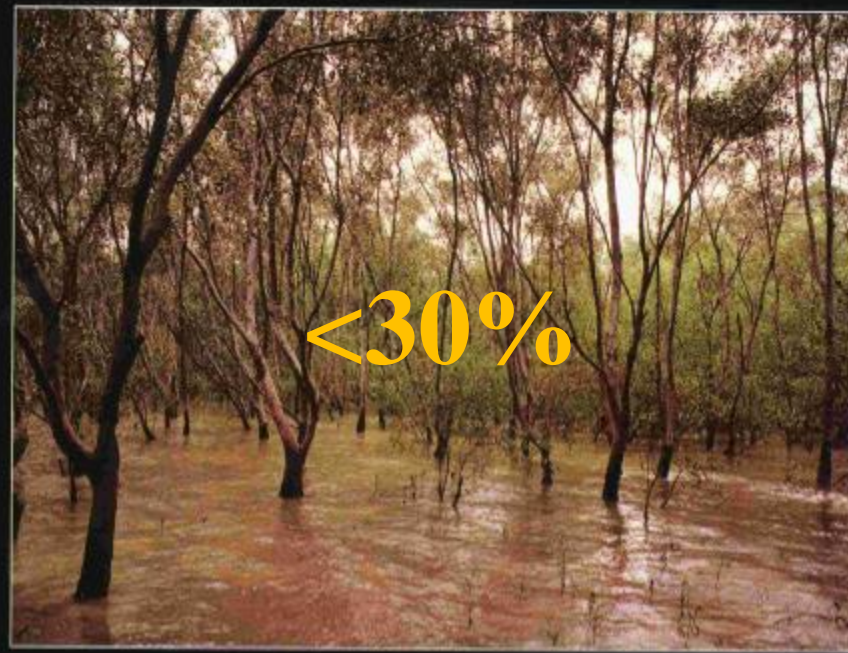
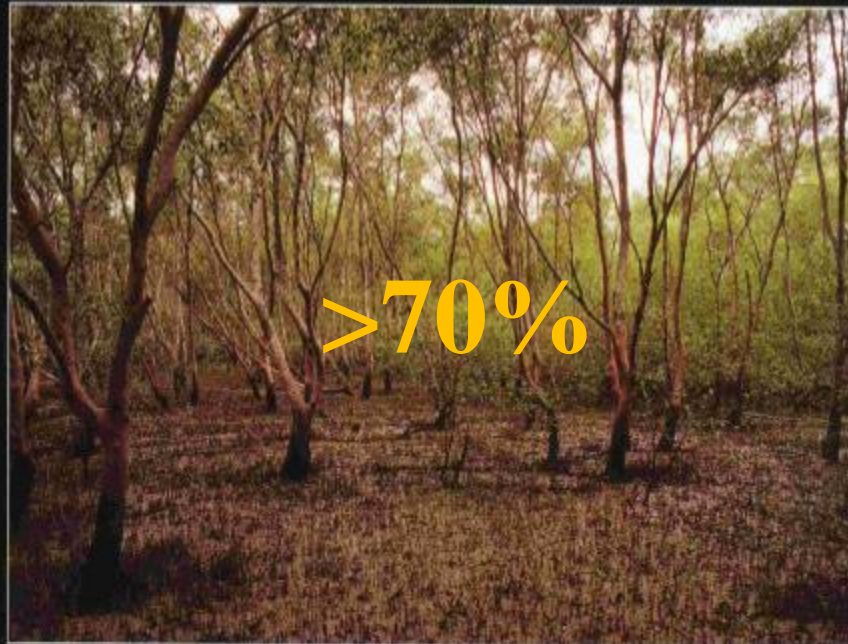
<30%

View of the same part of an inner forest at high tide (top) and at low tide (below). It is assumed that both regular tidal fluctuations and extraordinary flooding events are vital for mangrove habitats as they wash out or dilute excessive salts, organic debris and toxic substances in the upper soil surface. If inundations are absent for long periods the soil gradually dries out. Then the mangrove area may be colonised by other halophytes that find the conditions favourable.

>70%

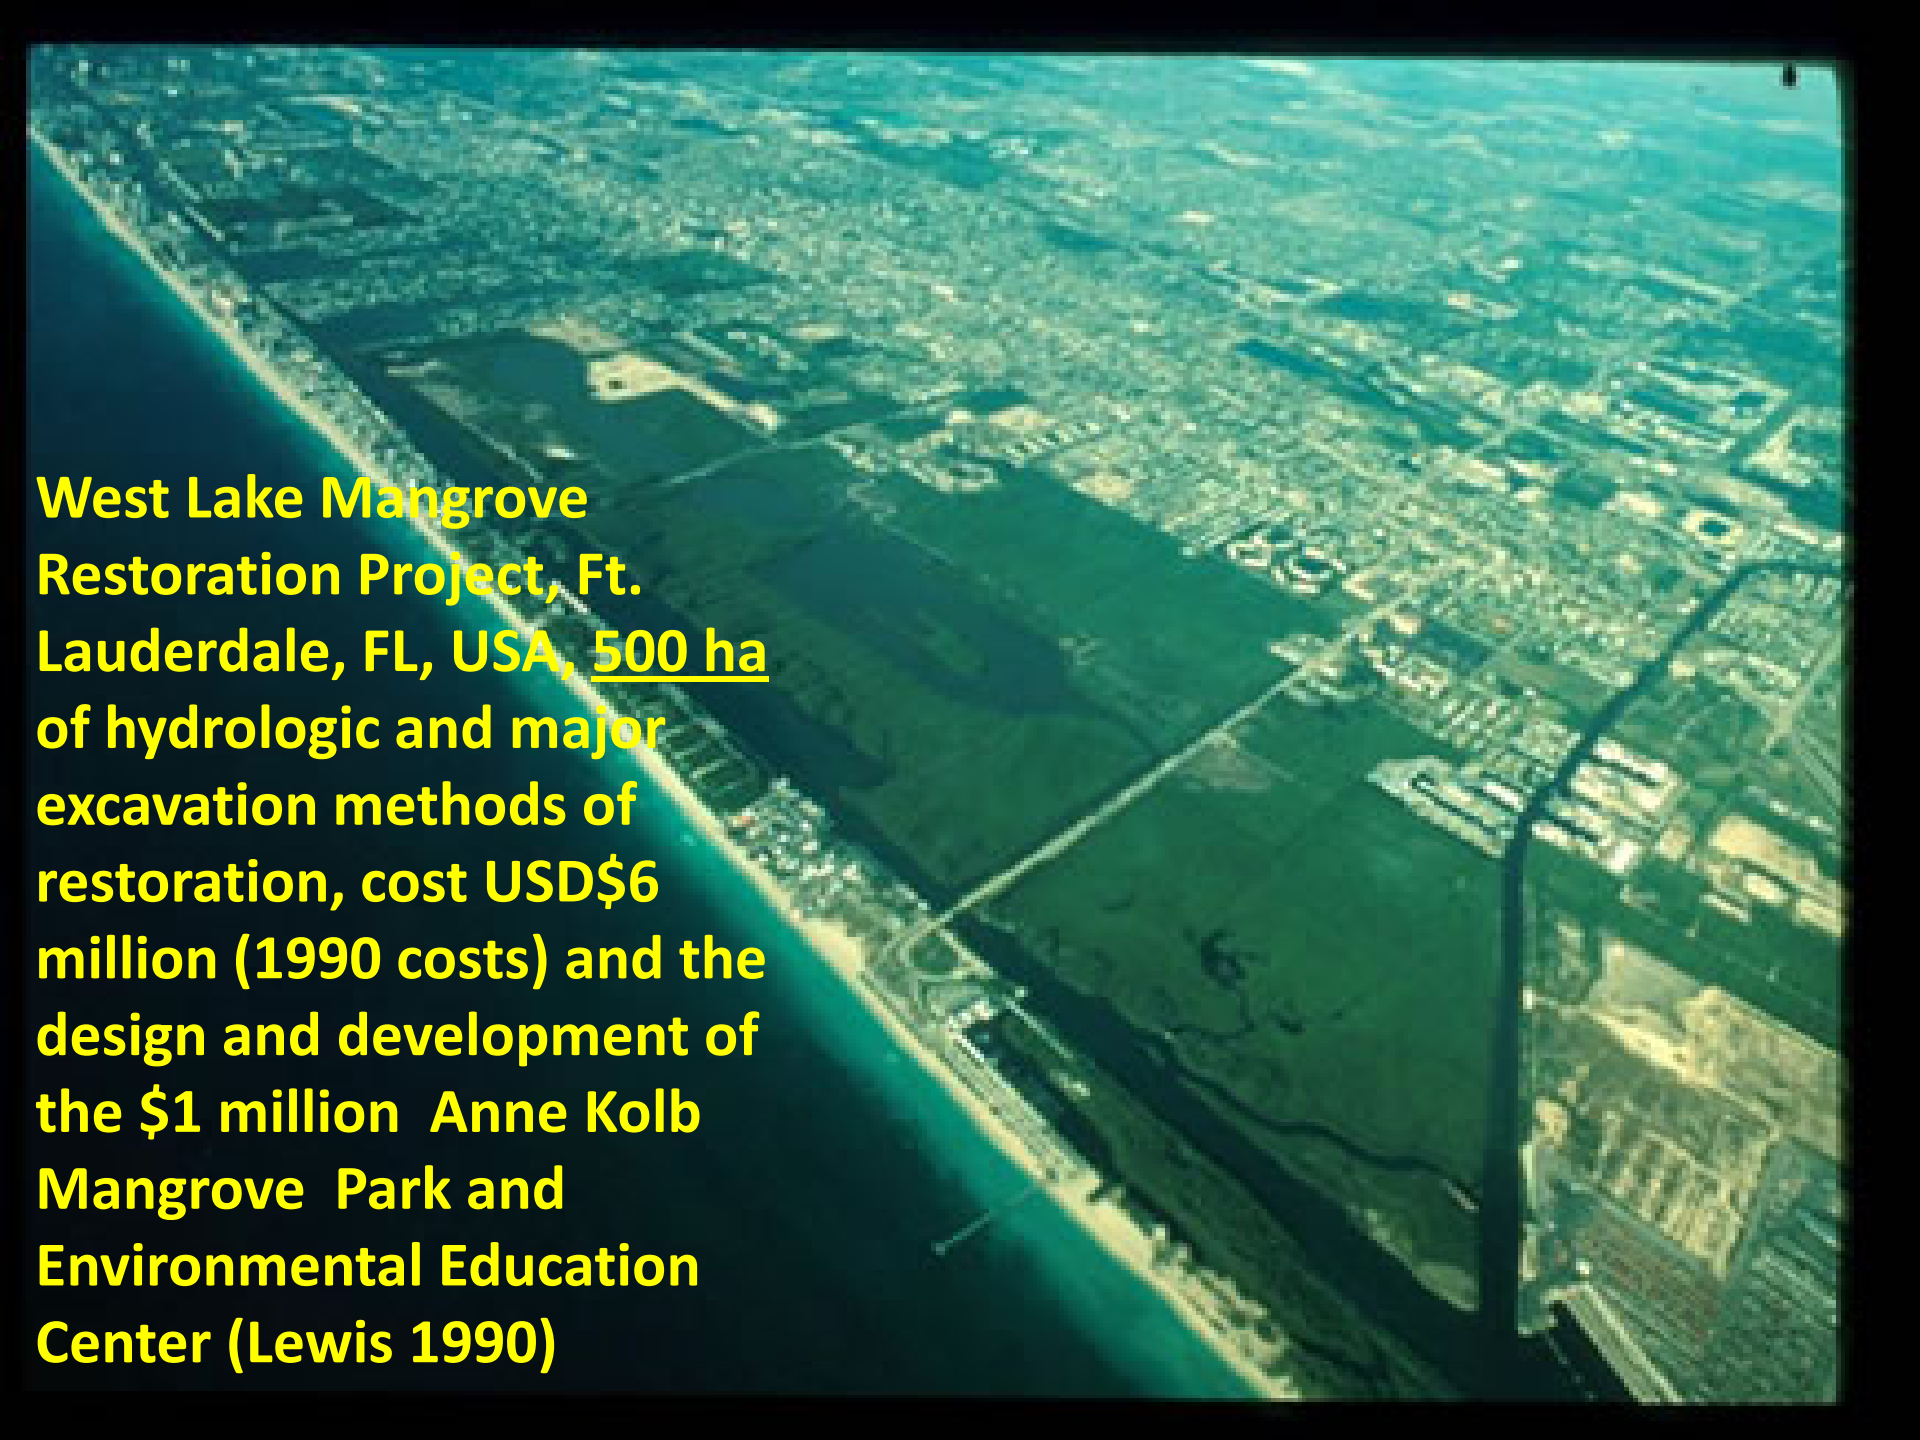
**West Lake Mangrove
Restoration Project, Ft.
Lauderdale, FL, USA, 500 ha
of hydrologic and major
excavation methods of
restoration, cost USD\$6
million (1990 costs) and the
design and development of
the \$1 million Anne Kolb
Mangrove Park and
Environmental Education
Center (Lewis 1990)**

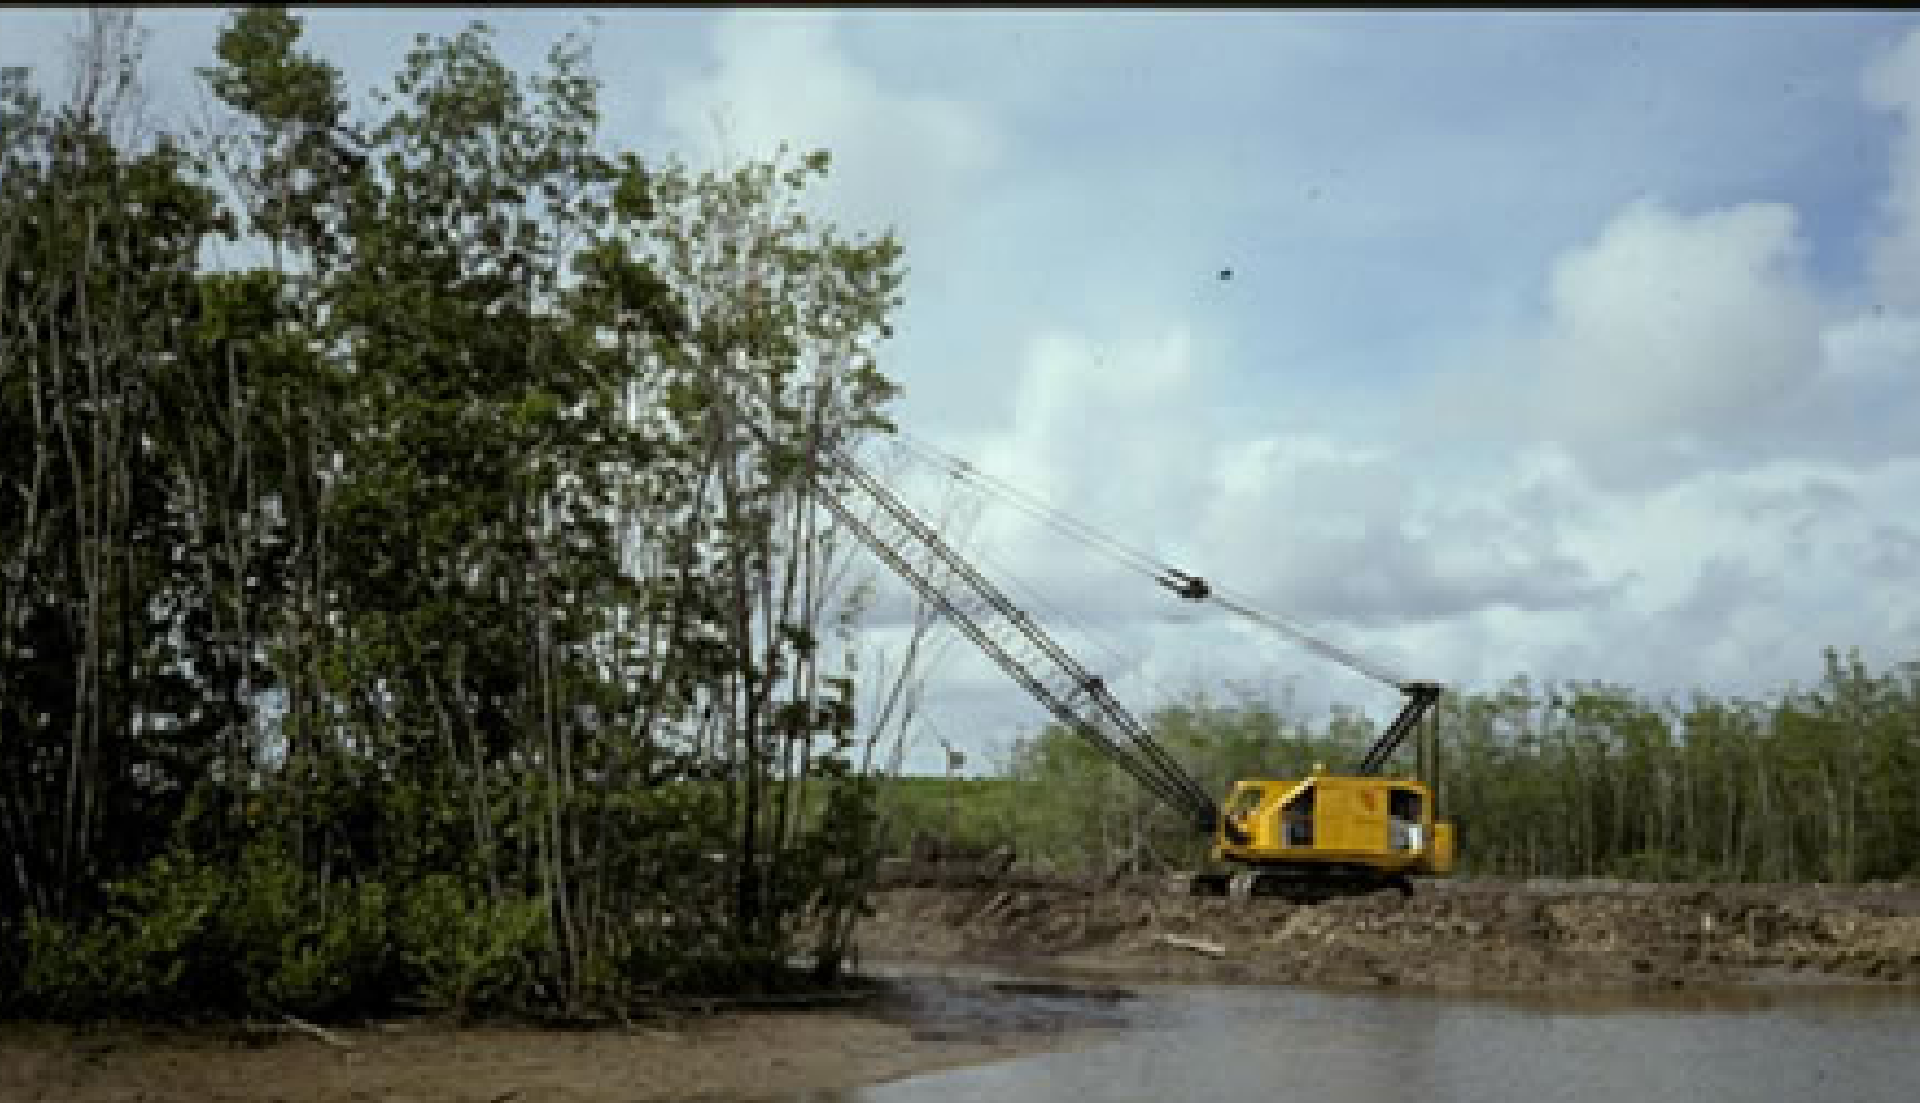
80 ha of Excavation of Dredged Material Deposits (Spoil) to Restore Mangroves, 420 ha of Hydrologic Restoration Through Channel Restoration

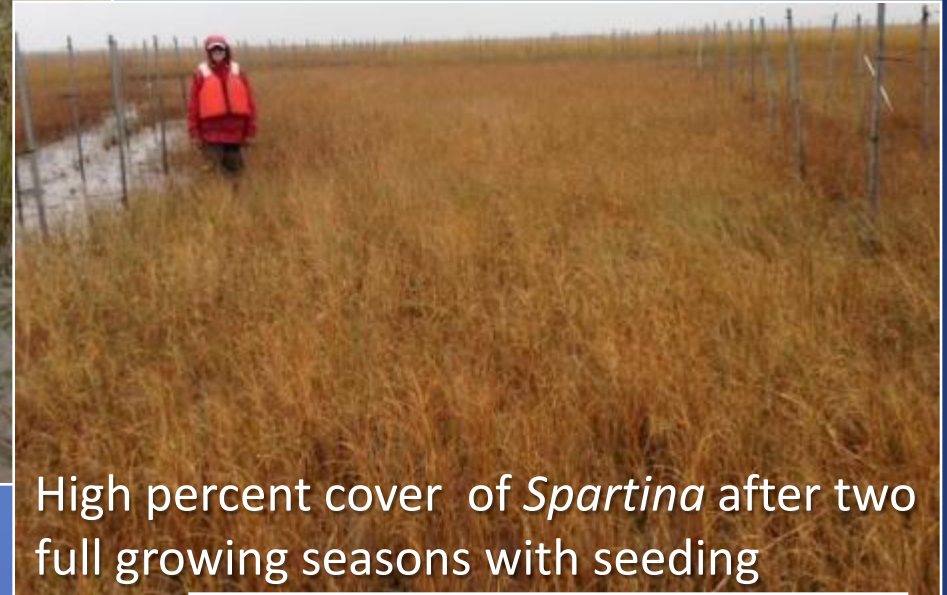
High percent cover of *Spartina* after two full growing seasons with seeding

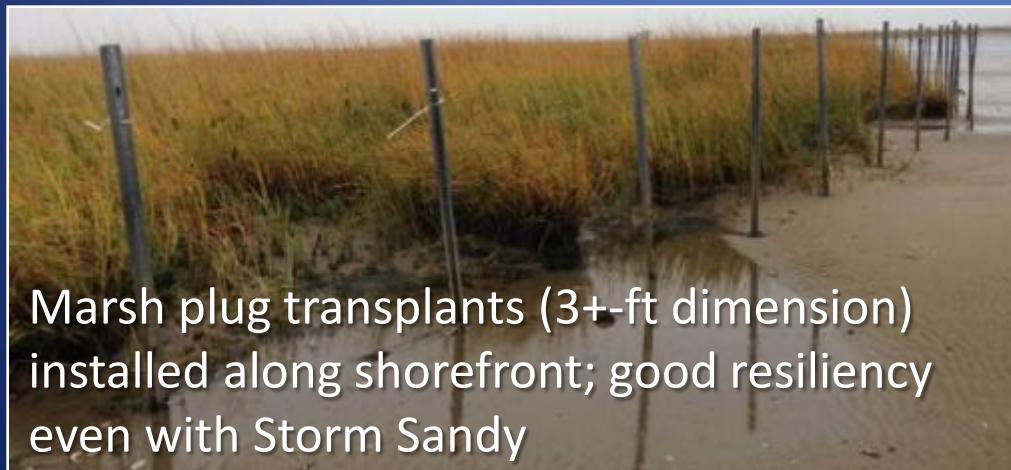
Marsh plug transplants (3+-ft dimension) installed along shoreline; good resiliency even with Storm Sandy

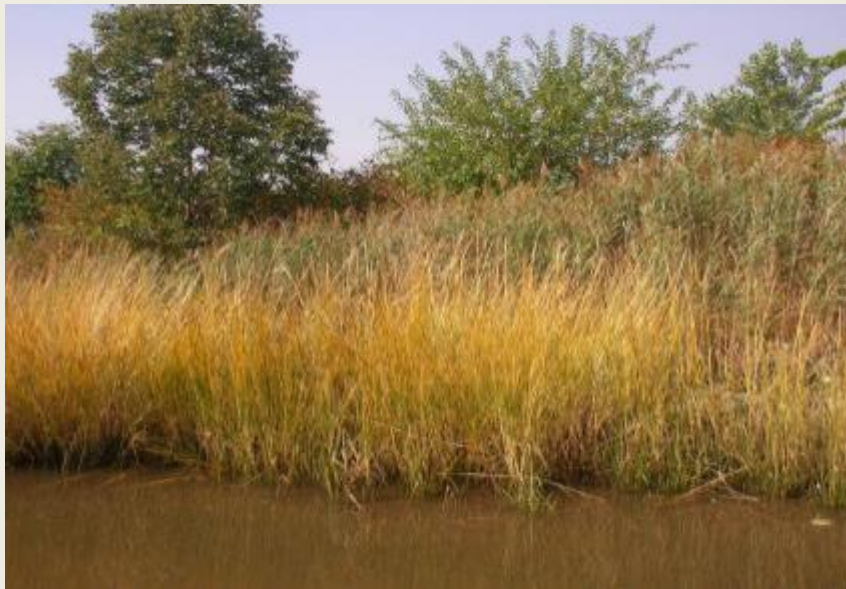
Where is *Spartina*?

- Upper limit at about river mile 2.7
- Habitat conditions are a factor

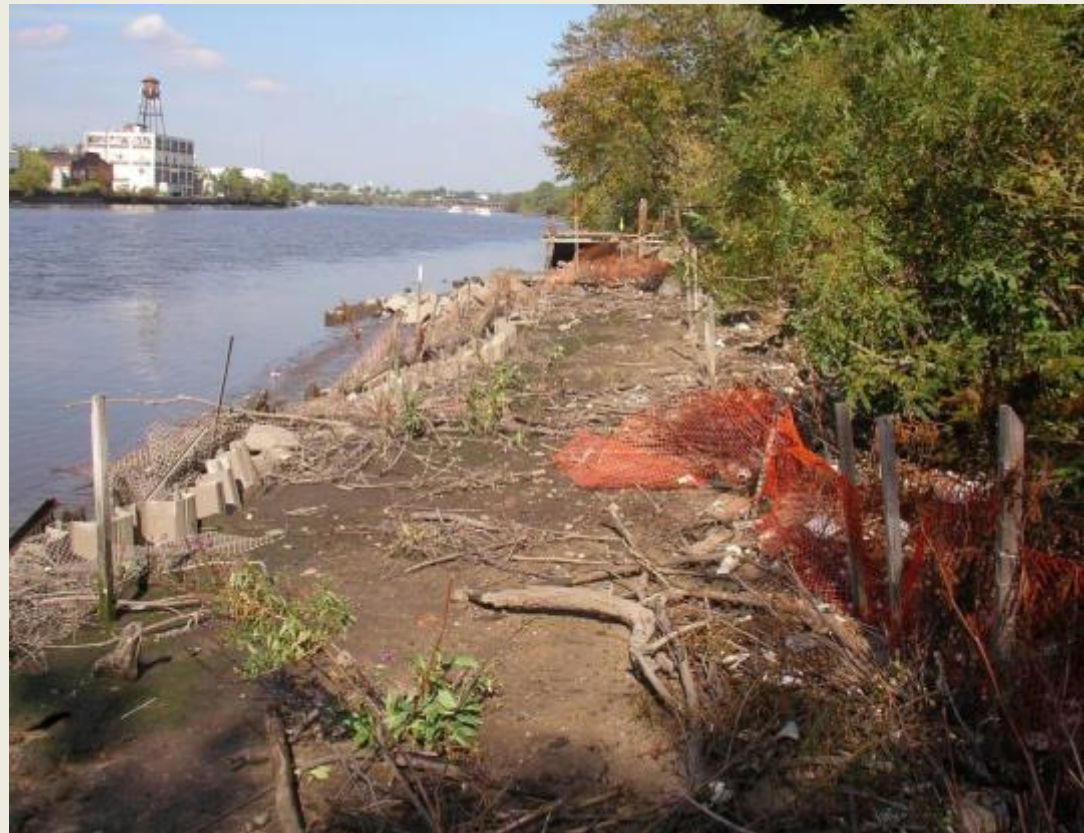
Local Wetland Restoration Effort – Why did it Fail?

- Located above elevation benchmarks for *S. alterniflora* in system
- Constraints from outside impacts
 - Geese
 - Floatables
 - Ice
- Requires extensive engineering to overcome constraints
